# Access Compliance Report

## Public Rights-of-Way

### (Curb Ramps)

Intersection ID: 25958	Main Street: KINGFISHER_DR	Cross Street: PARK_RD	Location: NW
ADA ID: 64D9EC044833	Ramp Type: PerpDiag	Initial Pass/Fail: Fail	Overall Compliance: No
Codes/Mitigation Info/Possible Solution		Field Measurements/Component Compliance	
Severity Score: 58.75

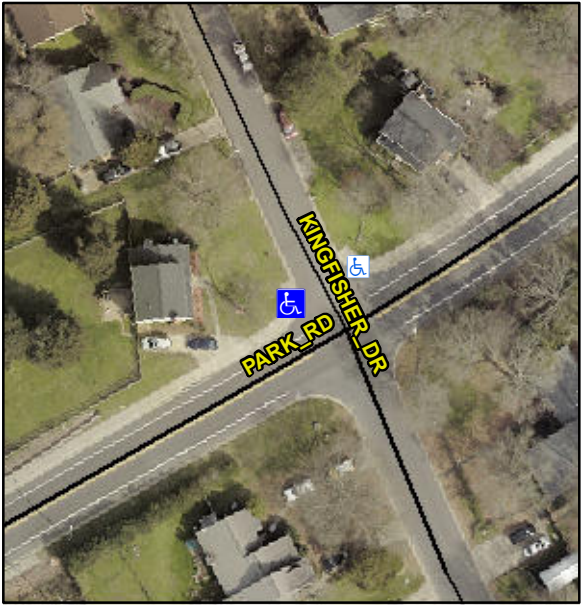
Possible Solutions:		Compliance	Description	Data	Compliance	Description	Data
	Remove & Replace Curb Ramp With Two New Directional Ramps or Equivalent.		N/A	Ramp Length (in)	69.0	No	Ramp Slope (%)	13.2
<p>Surveyor Notes:</p> <p>N/A</p> <p>PROW/ADA:</p> <p>R304.5.1, R304.2.2, R304.5.3</p>			No	Ramp Width (in)	46.0	No	Ramp XSlope (%)	7.4
			N/A	Flare Type LT	N/A	N/A	Flare Type RT	N/A
<p>Street 1 Name</p> <p>Stop Condition-Street 2</p> <p>Street 2 Name</p> <p>Stop Condition-Street 1</p>			N/A	Flare Slope LT (%)	N/A	N/A	Flare Slope RT (%)	N/A
			N/A	Flare Traversable LT?	N/A	N/A	Flare Traversable RT?	N/A
<p>Total Cost:</p> <p>\$ 3200.00</p>			N/A	Landing Length (in)	N/A	N/A	DWS Provided?	N/A
			N/A	Landing Width (in)	N/A	N/A	DWS Contrast?	N/A
			N/A	Landing Slope (%)	N/A	N/A	DWS Length (in)	N/A
			N/A	Landing X Slope (%)	N/A	N/A	DWS Full Width?	N/A
			N/A	Landing Curb? (Y/N)	N/A	N/A	DWS Offset (in)	N/A

N/A	Shared Landing?	N/A			
			N/A	Gutter Ponding?	N/A	N/A	Gutter Slope (%)	N/A
			N/A	Gutter Lip Ht (in)	N/A	N/A	Gutter X Slope (%)	N/A
			N/A	Painted X Walk1?	No	N/A	Painted X Walk2?	No
				X Walk 1 Direction	To S		X Walk 2 Direction	To E
			N/A	X Walk 1 Width (in)	N/A	N/A	X Walk 2 Width (in)	N/A
				X Walk 1 Slope (%)	5.0		X Walk 2 Slope (%)	0.7
				X Walk 1 X Slope (%)	3.4		X Walk 2 X Slope (%)	1.8
			N/A	Ramp inside XWalk1?	N/A	N/A	Ramp inside XWalk2?	N/A
				Road Slope (%)	5.4	N/A	Clear Space?	N/A
				Road X Slope (%)	0.3	N/A	Clear Space to XWalk (in)	N/A
			N/A	Any Obstructions?	N/A	N/A	Storm Grate/Utility Hazard?	N/A
				Obstruction Type			Storm Grate/Utility Type	
			N/A			N/A		N/A
			Yes	Surface Condition? (G/P)				Good
