Access Compliance Report

Public Rights-of-Way

(Curb Ramps)

| Intersection ID: 46496 | Main Street: BERE_ISLAND_DR | Cross Street: TRAILWATER_RD | Location: SW |

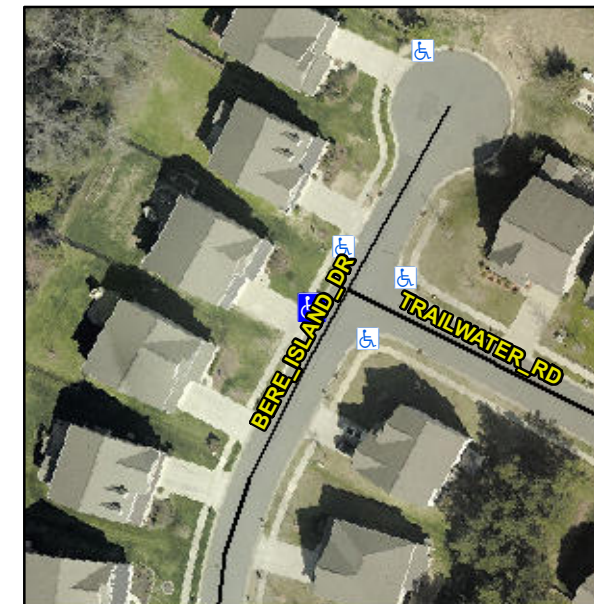
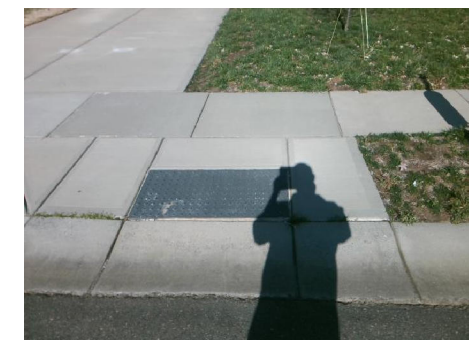
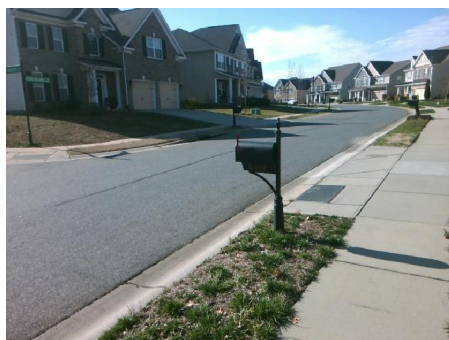
| ADA ID: 64DA9CFBA2AB | Ramp Type: Perp | Initial Pass/Fail: Pass | Overall Compliance: No |

Not Found, R304.2.1, R304.2.2-Perp, R304.3.2-Para

| Compliance | Description | Data | Compliance | Description | Data |
|---|---|---|---|---|---|
| No | Landing Length (in) | 47.0 | Yes | DWS Provided? | Yes |
| No | Landing Slope (%) | 3.2 | Yes | DWS Length (in) | 24.0 |

Remove & Replace Entire Ramp.

Total Cost: \$ 1850.00
