Access Compliance Report

Public Rights-of-Way

(Curb Ramps)

Intersection ID: 44450	Main Street: BAYVIEW_PY	Cross Street: DONNELLSON_COMMON_CT	Location: SW
ADA ID: 64E9F682C856	Ramp Type: PerpDiag	Initial Pass/Fail: Fail	Overall Compliance: No
Codes/Mitigation Info/Possible Solution		Field Measurements/Component Compliance	
Severity Score: 8.75

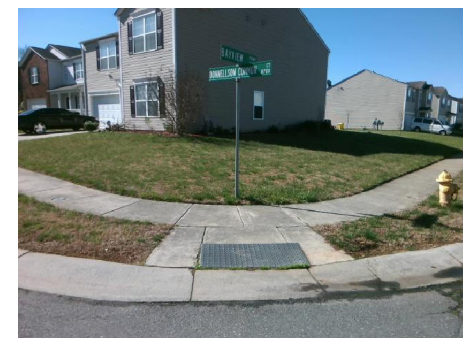
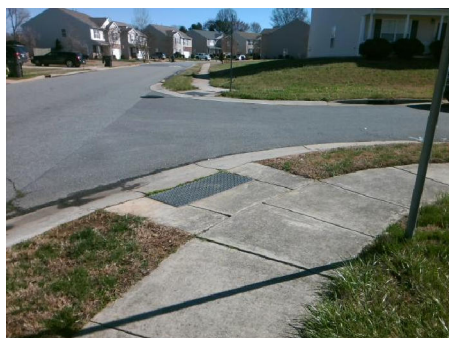
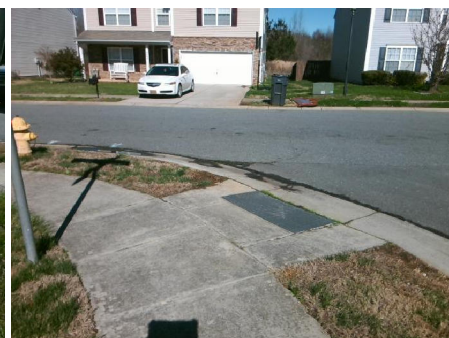
Not Found, R304.5.1

Compliance	Description	Data	Compliance	Description	Data
N/A	Ramp Length (in)	49.0	Yes	Ramp Slope (%)	8.0
No	Ramp Width (in)	40.0	Yes	Ramp XSlope (%)	1.4
N/A	Flare Type LT	N/A	N/A	Flare Type RT	N/A
N/A	Flare Slope LT (%)	N/A	N/A	Flare Slope RT (%)	N/A
N/A	Flare Traversable LT?	N/A	N/A	Flare Traversable RT?	N/A
N/A	Landing Length (in)	N/A	N/A	DWS Provided?	N/A
N/A	Landing Width (in)	N/A	N/A	DWS Contrast?	N/A
N/A	Landing Slope (%)	N/A	N/A	DWS Length (in)	N/A
N/A	Landing X Slope (%)	N/A	N/A	DWS Full Width?	N/A
N/A	Landing Curb? (Y/N)	N/A	N/A	DWS Offset (in)	N/A
N/A	Shared Landing?	N/A			
N/A	Gutter Ponding?	N/A	N/A	Gutter Slope (%)	N/A
N/A	Gutter Lip Ht (in)	N/A	N/A	Gutter X Slope (%)	N/A
N/A	Painted X Walk1?	No	N/A	Painted X Walk2?	No
	X Walk 1 Direction	To E		X Walk 2 Direction	To N
N/A	X Walk 1 Width (in)	N/A	N/A	X Walk 2 Width (in)	N/A
	X Walk 1 Slope (%)	0.9		X Walk 2 Slope (%)	5.3
	X Walk 1 X Slope (%)	0.3		X Walk 2 X Slope (%)	1.3

N/A	Ramp inside XWalk1?	N/A	N/A	Ramp inside XWalk2?	N/A
	Road Slope (%)	0.3	N/A	Clear Space?	N/A
	Road X Slope (%)	1.5	N/A	Clear Space to XWalk (in)	N/A
N/A	Any Obstructions?	N/A	N/A	Storm Grate/Utility Hazard?	N/A
	Obstruction Type			Storm Grate/Utility Type	
		N/A			N/A
			Yes	Surface Condition? (G/P)	Good

Possible Solutions:

Remove & Replace Curb Ramp With Two New Directional Ramps or Equivalent.
