# Access Compliance Report

## Public Rights-of-Way

### (Curb Ramps)

Intersection ID: N/A	Main Street: AGNEW_DR	Cross Street: COWGILL_LN	Location: NW
ADA ID: 64EEDFFC1E6A	Ramp Type: Perp	Initial Pass/Fail: Fail	Overall Compliance: No
Severity Score: 10			
Codes/Mitigation Info/Possible Solution		Field Measurements/Component Compliance

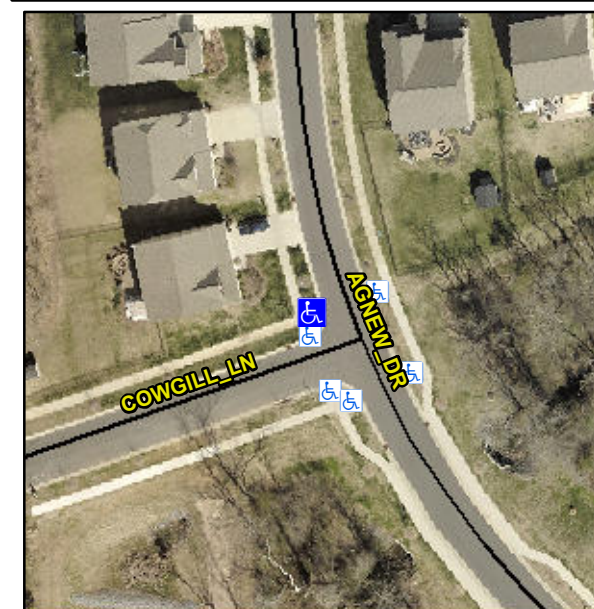
**Not Found, R304.5.1, R304.5.3**

Compliance	Description	Data	Compliance	Description	Data
N/A	Ramp Length (in)	99.0	Yes	Ramp Slope (%)	3.4
No	Ramp Width (in)	39.0	No	Ramp XSlope (%)	3.2
N/A	Flare Type LT	N/A	N/A	Flare Type RT	N/A
N/A	Flare Slope LT (%)	N/A	N/A	Flare Slope RT (%)	N/A
N/A	Flare Traversable LT?	N/A	N/A	Flare Traversable RT?	N/A
N/A	Landing Length (in)	N/A	N/A	DWS Provided?	N/A
N/A	Landing Width (in)	N/A	N/A	DWS Contrast?	N/A
N/A	Landing Slope (%)	N/A	N/A	DWS Length (in)	N/A
N/A	Landing X Slope (%)	N/A	N/A	DWS Full Width?	N/A
N/A	Landing Curb? (Y/N)	N/A	N/A	DWS Offset (in)	N/A
N/A	Shared Landing?	N/A			
N/A	Gutter Ponding?	N/A	N/A	Gutter Slope (%)	N/A
N/A	Gutter Lip Ht (in)	N/A	N/A	Gutter X Slope (%)	N/A
N/A	Painted X Walk1?	No	N/A	Painted X Walk2?	N/A
	X Walk 1 Direction	To NE		X Walk 2 Direction	N/A
N/A	X Walk 1 Width (in)	N/A	N/A	X Walk 2 Width (in)	N/A
	X Walk 1 Slope (%)	2.4		X Walk 2 Slope (%)	N/A
	X Walk 1 X Slope (%)	2.6		X Walk 2 X Slope (%)	N/A

N/A	Ramp inside XWalk1?	N/A	N/A	Ramp inside XWalk2?	N/A
	Road Slope (%)	N/A	N/A	Clear Space?	N/A
	Road X Slope (%)	N/A	N/A	Clear Space to XWalk (in)	N/A
N/A	Any Obstructions?	N/A	N/A	Storm Grate/Utility Hazard?	N/A
	Obstruction Type			Storm Grate/Utility Type	
		N/A			N/A
			Yes	Surface Condition? (G/P)	Good

**Remove & Replace Entire Ramp.**

Total Cost: \$ 1850.00
