Access Compliance Report Public Rights-of-Way (Curb Ramps)

Intersection ID: 7963 Main Street: ASHFORD_ST Cross Street: DAVID_AV Location: N/A **Overall Compliance: No** ADA ID: 64EF8A954F72 Ramp Type: Perp Initial Pass/Fail: Fail **Severity Score:** 10

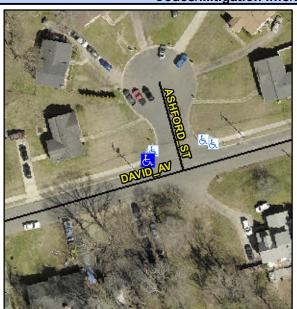
| Ossible Solution | | | |
|---|---|--|--|
| Not Found, R304.5.1 | N | | |

| Field Measurements/Component Compliance | | | | | | | |
|---|---|---|---|---|---|--|--|
| No | Ramp Width (in) | 47.0 | Yes | Ramp XSlope (%) | 3.1 | | |

| Ossible Solution | | | |
|---|---|--|--|
| Remove & Replace Entire Ramp. | | | |
