## Access Compliance Report Public Rights-of-Way (Curb Ramps)

Intersection ID: 52550 Main Street: MEADOW\_BOTTOM\_RD Cross Street: KRISTENS\_MARE\_DR Location: N

ADA ID: 6500941DD1C3 Ramp Type: Perpendicular Diagonal Initial Pass/Fail: Fail Overall Compliance: No Severity Score: 12.5

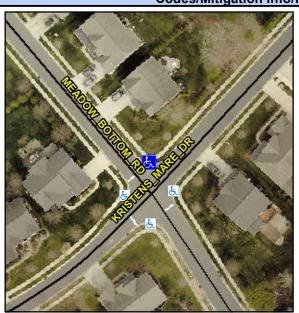
PROW/ADA:
Not Found, R304.2.2

Field Measure	ements/C	ompo	nent Compliance	
Comp	Compliance Description		Comp	liance Description	Data
N/A	Ramp Length (in)	47.0	No	Ramp Slope (%)	9.4
Yes	Ramp Width (in)	48.0	Yes	Ramp XSlope (%)	0.7
N/A	Flare Type LT	N/A	N/A	Flare Type RT	N/A
N/A	Flare Slope LT (%)	N/A	N/A	Flare Slope RT (%)	N/A
N/A	Flare Traversable LT?	N/A	N/A	Flare Traversable RT?	N/A
N/A	Landing Length (in)	N/A	N/A	DWS Provided?	N/A
N/A	Landing Width (in)	N/A	N/A	DWS Contrast?	N/A
N/A	Landing Slope (%)	N/A	N/A	DWS Length (in)	N/A
N/A	Landing X Slope (%)	N/A	N/A	DWS Full Width?	N/A
N/A	Landing Curb? (Y/N)	N/A	N/A	DWS Offset (in)	N/A
N/A	Shared Landing?	N/A			
N/A	Gutter Ponding?	N/A	N/A	Gutter Slope (%)	N/A
N/A	Gutter Lip Ht (in)	N/A	N/A	Gutter X Slope (%)	N/A
N/A	Painted X Walk1?	No	N/A	Painted X Walk2?	No
	X Walk 1 Direction	To SW		X Walk 2 Direction	To SE
N/A	X Walk 1 Width (in)	N/A	N/A	X Walk 2 Width (in)	N/A
	X Walk 1 Slope (%)	2.2		X Walk 2 Slope (%)	0.8

X Walk 1 X Slope (%)	2.1		X Walk 2 X Slope (%)	1.6
N/A	Ramp inside XWalk1?	N/A	N/A	Ramp inside XWalk2?	N/A
	Road Slope (%)	0.0	N/A	Clear Space?	N/A
	Road X Slope (%)	0.3	N/A	Clear Space to XWalk (in)	N/A
N/A	Any Obstructions?	N/A	N/A	Storm Grate/Utility Hazard?	N/A
	Obstruction Type		l	Storm Grate/Utility Type	
		N/A			N/A
			Yes	Surface Condition? (G/P)	Good

Remove & Replace Curb Ramp With
Two New Directional Ramps or
Equivalent.
