# Access Compliance Report

## Public Rights-of-Way

### (Curb Ramps)

Intersection ID: N/A	Main Street: W_T_HARRIS_BV	Cross Street: HARRIS_PARK_DR	Location: SE
ADA ID: 650257C778A4	Ramp Type: Perpendicular Diagonal	Initial Pass/Fail: Fail	Overall Compliance: No
Severity Score: 33.75			
Codes/Mitigation Info/Possible Solution		Field Measurements/Component Compliance

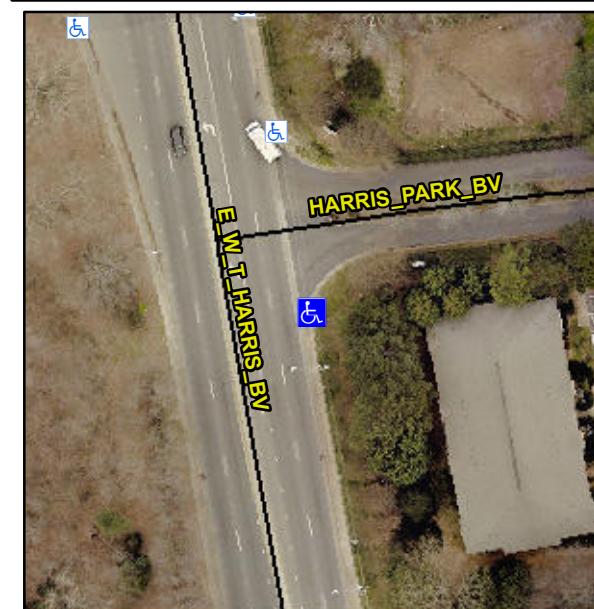
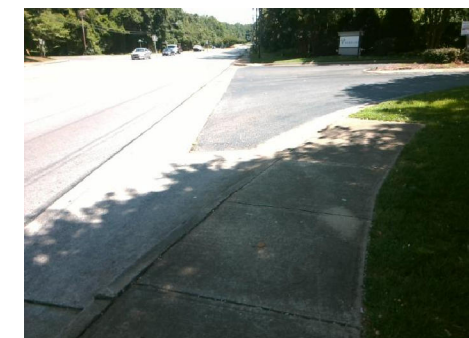
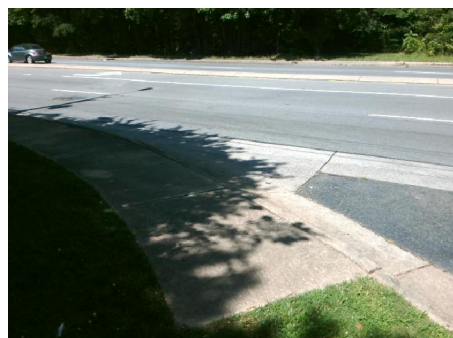
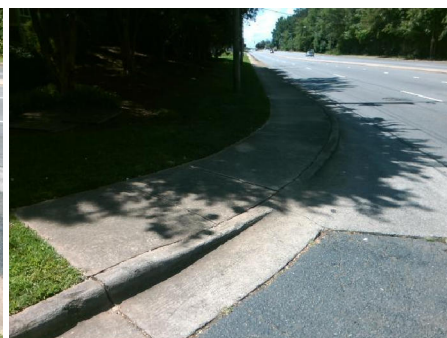
**Not Found, R304.5.1, R304.2.2, R304.5.3**

Compliance	Description	Data	Compliance	Description	Data
N/A	Ramp Length (in)	60.0	No	Ramp Slope (%)	9.5
No	Ramp Width (in)	46.0	No	Ramp XSlope (%)	6.3
N/A	Flare Type LT	N/A	N/A	Flare Type RT	N/A
N/A	Flare Slope LT (%)	N/A	N/A	Flare Slope RT (%)	N/A
N/A	Flare Traversable LT?	N/A	N/A	Flare Traversable RT?	N/A
N/A	Landing Length (in)	N/A	N/A	DWS Provided?	N/A
N/A	Landing Width (in)	N/A	N/A	DWS Contrast?	N/A
N/A	Landing Slope (%)	N/A	N/A	DWS Length (in)	N/A
N/A	Landing X Slope (%)	N/A	N/A	DWS Full Width?	N/A
N/A	Landing Curb? (Y/N)	N/A	N/A	DWS Offset (in)	N/A
N/A	Shared Landing?	N/A			
N/A	Gutter Ponding?	N/A	N/A	Gutter Slope (%)	N/A
N/A	Gutter Lip Ht (in)	N/A	N/A	Gutter X Slope (%)	N/A
N/A	Painted X Walk1?	No	N/A	Painted X Walk2?	No
	X Walk 1 Direction	To N		X Walk 2 Direction	To W
N/A	X Walk 1 Width (in)	N/A	N/A	X Walk 2 Width (in)	N/A
	X Walk 1 Slope (%)	0.9		X Walk 2 Slope (%)	0.4
	X Walk 1 X Slope (%)	7.7		X Walk 2 X Slope (%)	0.1

N/A	Ramp inside XWalk1?	N/A	N/A	Ramp inside XWalk2?	N/A
	Road Slope (%)	4.0	N/A	Clear Space?	N/A
	Road X Slope (%)	3.2	N/A	Clear Space to XWalk (in)	N/A
N/A	Any Obstructions?	N/A	N/A	Storm Grate/Utility Hazard?	N/A
	Obstruction Type			Storm Grate/Utility Type	
		N/A			N/A
			Yes	Surface Condition? (G/P)	Good

**Remove & Replace Curb Ramp With Two New Directional Ramps or Equivalent.**
