Access Compliance Report

Public Rights-of-Way

(Curb Ramps)

Intersection ID: 19406	Main Street: SOUTH_BV	Cross Street: BOURBON_ST	Location: NE
ADA ID: 650A8BE0F571	Ramp Type: Directional1	Initial Pass/Fail: Fail	Overall Compliance: No
Severity Score: 12.5			
Codes/Mitigation Info/Possible Solution		Field Measurements/Component Compliance

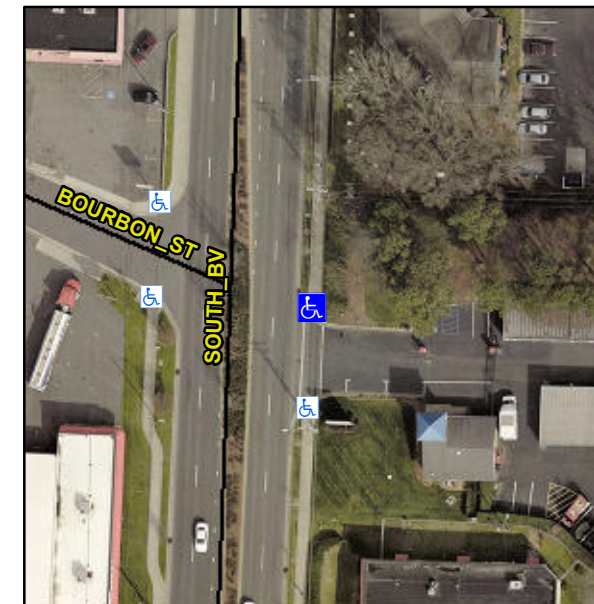
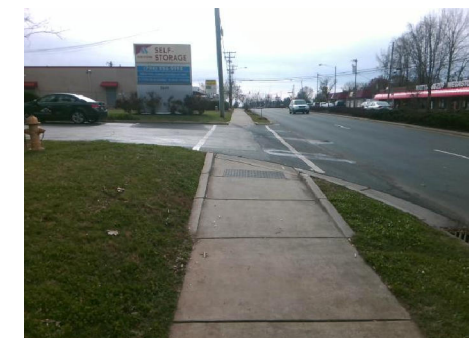
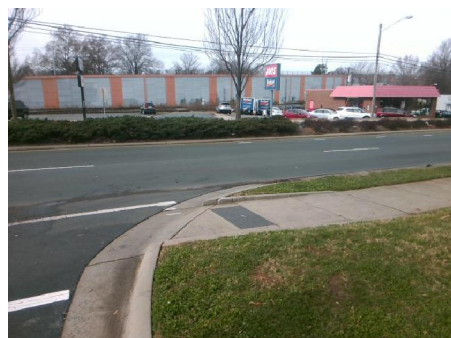
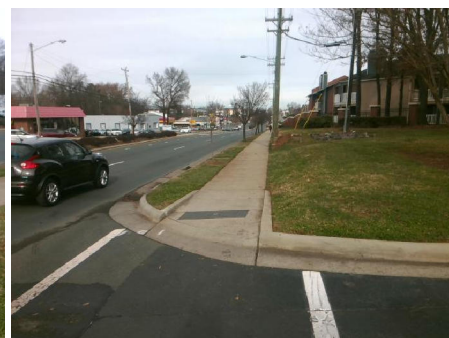
Compliance	Description	Data	Compliance	Description	Data
N/A	Ramp Length (in)	123.0	N/A	Grade Break?	N/A
Yes	Ramp Width (in)	70.0	N/A	Grade Break Slope (%)	0.0
Yes	Ramp Slope (%)	5.2	N/A	Grade Break XSlope (%)	0.0
No	Ramp XSlope (%)	6.7			
N/A	Flare Type LT	N/A	N/A	Flare Type RT	N/A
N/A	Flare Slope LT (%)	N/A	N/A	Flare Slope RT (%)	0.0
N/A	Flare Traversable LT?	N/A	N/A	Flare Traversable RT?	N/A
N/A	Landing Length (in)	0.0	N/A	DWS Provided?	N/A
N/A	Landing Width (in)	0.0	N/A	DWS Contrast?	N/A
N/A	Landing Slope (%)	0.0	N/A	DWS Length (in)	N/A
N/A	Landing X Slope (%)	0.0	N/A	DWS Full Width?	N/A
N/A	Landing Curb? (Y/N)	N/A	N/A	DWS Offset LT (in)	N/A
N/A	Shared Landing?	N/A	N/A	DWS Offset RT (in)	N/A
N/A	Gutter Ponding?	0.0	N/A	Gutter Slope (%)	N/A
N/A	Gutter Lip Ht (in)	0.0	N/A	Gutter X Slope (%)	N/A
N/A	Painted X Walk1?	Yes		Road Slope (%)	0.3
	X Walk 1 Direction	To S		Road X Slope (%)	7.0
	X Walk 1 Width (in)	110.0		Clear Space?	N/A

X Walk 1 Slope (%)	0.3	N/A	Clear Space to XWalk (in)	N/A
	X Walk 1 X Slope (%)	7.0	N/A	Storm Grate/Utility Hazard?	N/A
N/A	Ramp inside XWalk1?	Yes		Storm Grate/Utility Type	
N/A	Any Obstructions?	N/A			N/A
	Obstruction Type		Yes	Surface Condition? (G/P)	Good
			N/A	Curb Slope (%)	12.3

Possible Solutions:

Remove & Replace Entire Ramp.

R304.5.3
