# Access Compliance Report

## Public Rights-of-Way

### (Curb Ramps)

| Intersection ID: 26458 | Main Street: BRECHIN_DR | Cross Street: BROADFORD_CT | Location: SW |

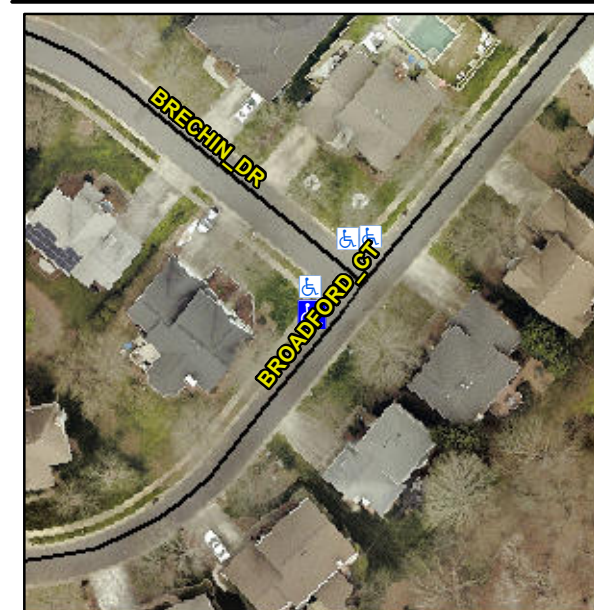
| ADA ID: 650C375888DA | Ramp Type: Perpendicular | Initial Pass/Fail: Fail | Overall Compliance: No |
| Severity Score: 12.5 | | | |

**R304.2.2**

| Compliance | Description | Data | Compliance | Description | Data |
|---|---|---|---|---|---|
| N/A | Ramp Length (in) | 45.0 | No | Ramp Slope (%) | 10.0 |

**Remove & Replace Entire Ramp.**

**\$ 1850.00**
