# Access Compliance Report

## Public Rights-of-Way

### (Curb Ramps)

Intersection ID: 43227	Main Street: N I-77 EXIT 5 RA	Cross Street: N I-77 HY	Location: SW
ADA ID: 6512E9F9D8D9	Ramp Type: Perpendicular	Initial Pass/Fail: Fail	Overall Compliance: No
Codes/Mitigation Info/Possible Solution			Severity Score: 10
			Field Measurements/Component Compliance

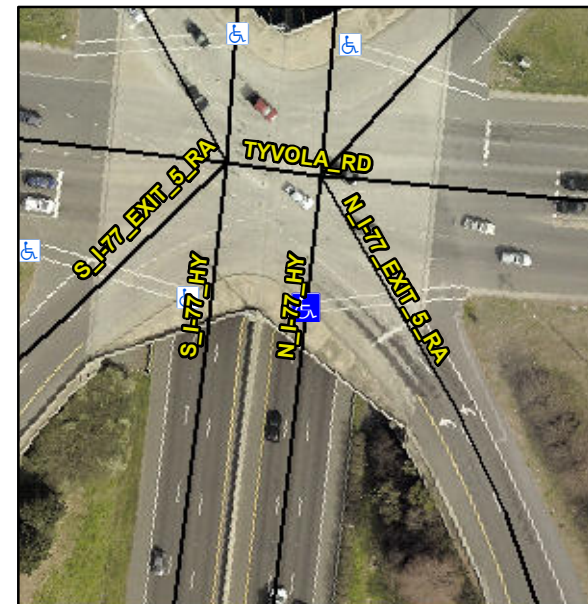
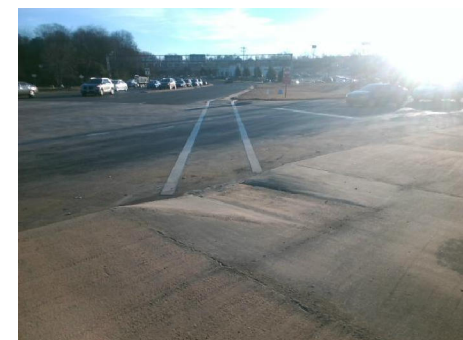
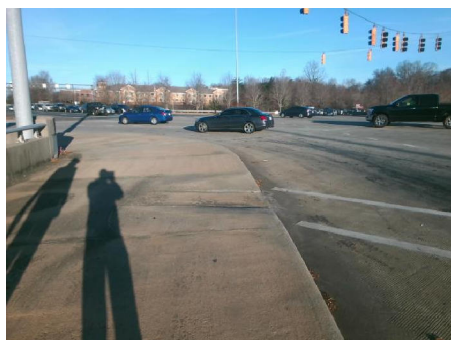
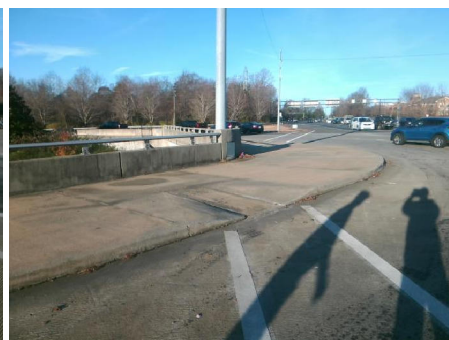
Compliance	Description	Data	Compliance	Description	Data
N/A	Ramp Length (in)	96.0	Yes	Ramp Slope (%)	6.4
No	Ramp Width (in)	40.0	No	Ramp XSlope (%)	4.3
N/A	Flare Type LT	N/A	N/A	Flare Type RT	N/A
N/A	Flare Slope LT (%)	N/A	N/A	Flare Slope RT (%)	N/A
N/A	Flare Traversable LT?	N/A	N/A	Flare Traversable RT?	N/A
N/A	Landing Length (in)	N/A	N/A	DWS Provided?	N/A
N/A	Landing Width (in)	N/A	N/A	DWS Contrast?	N/A
N/A	Landing Slope (%)	N/A	N/A	DWS Length (in)	N/A
N/A	Landing X Slope (%)	N/A	N/A	DWS Full Width?	N/A
N/A	Landing Curb? (Y/N)	N/A	N/A	DWS Offset (in)	N/A
N/A	Shared Landing?	N/A			
N/A	Gutter Ponding?	N/A	N/A	Gutter Slope (%)	N/A
N/A	Gutter Lip Ht (in)	N/A	N/A	Gutter X Slope (%)	N/A
N/A	Painted X Walk1?	Yes	N/A	Painted X Walk2?	N/A
	X Walk 1 Direction	To E		X Walk 2 Direction	N/A
N/A	X Walk 1 Width (in)	55.0	N/A	X Walk 2 Width (in)	N/A
	X Walk 1 Slope (%)	0.9		X Walk 2 Slope (%)	N/A
	X Walk 1 X Slope (%)	2.7		X Walk 2 X Slope (%)	N/A

N/A	Ramp inside XWalk1?	Yes	N/A	Ramp inside XWalk2?	N/A
	Road Slope (%)	N/A	N/A	Clear Space?	N/A
	Road X Slope (%)	N/A	N/A	Clear Space to XWalk (in)	N/A
N/A	Any Obstructions?	N/A	N/A	Storm Grate/Utility Hazard?	N/A
	Obstruction Type			Storm Grate/Utility Type	
		N/A			N/A
		Yes		Surface Condition? (G/P)	Good

Possible Solutions:

**Remove & Replace Entire Ramp.**
