Access Compliance Report Public Rights-of-Way (Curb Ramps)

Intersection ID: 54318	ction ID: 54318 Main Street: CANTERBURY_CASTLE_DR			Street:	BELMONT_MANSION	Location:	SE		
ADA ID: 651B2DCE5380				Initial Pass/Fail: Fail Overall Compliance: No				o Severity Score:	21.25
Codes/Mitigation Info/Possible Solution				Field Measurements/Component Compliance					
		Possible Solutions:		Compliance Description Data Com			Comp	pliance Description Data

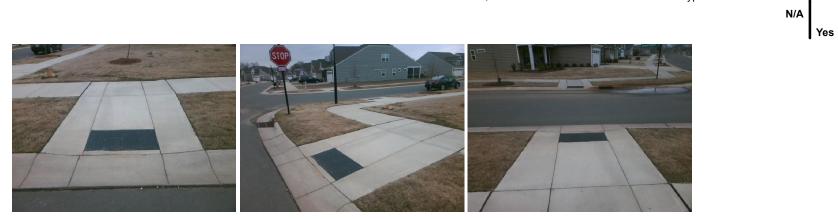
5:6.	Remove & Replace Entire Ram	D .	N/A	Ramp Length (in)	96.0	Yes	Ramp Slope (%)	5.2
				No	Ramp Width (in)	46.0	No	Ramp XSlope (%)	5.8
				N/A	Flare Type LT	N/A	N/A	Flare Type RT	N/A
	G	1		N/A	Flare Slope LT (%)	N/A	N/A	Flare Slope RT (%)	N/A
E CAN	LE DR			N/A	Flare Traversable LT?	N/A	N/A	Flare Traversable RT?	N/A
E E E E				N/A	Landing Length (in)	N/A	N/A	DWS Provided?	N/A
		Surveyor Notes:		N/A	Landing Width (in)	N/A	N/A	DWS Contrast?	N/A
		N/A		N/A	Landing Slope (%)	N/A	N/A	DWS Length (in)	N/A
				N/A	Landing X Slope (%)	N/A	N/A	DWS Full Width?	N/A
				N/A	Landing Curb? (Y/N)	N/A	N/A	DWS Offset (in)	N/A
				N/A	Shared Landing?	N/A			
		PROW/ADA:		N/A	Gutter Ponding?	N/A	N/A	Gutter Slope (%)	N/A
the car are de		Not Found, R304.5.1, R304.5.3		N/A	Gutter Lip Ht (in)	1.0	N/A	Gutter X Slope (%)	N/A
				N/A	Painted X Walk1?	No	N/A	Painted X Walk2?	N/A
					X Walk 1 Direction	To W		X Walk 2 Direction	N/A

N/A	X Walk 1 Width (in)	N/A	N/A	X Walk 2 Width (in)	N/A
Street 1 Name BELM	IONT MANSION DR				X Walk 1 Slope (%)	1.9		X Walk 2 Slope (%)	N/A
Stop Condition-Street 2	StopSign				X Walk 1 X Slope (%)	2.6		X Walk 2 X Slope (%)	N/A
Street 2 Name	N/A			N/A	Ramp inside XWalk1?	N/A	N/A	Ramp inside XWalk2?	N/A
Stop Condition-Street 1	N/A				Road Slope (%)	N/A	N/A	Clear Space?	N/A
					Road X Slope (%)	N/A	N/A	Clear Space to XWalk (in)	N/A
				N/A	Any Obstructions?	N/A	N/A	Storm Grate/Utility Hazard?	N/A
		Total Cost: \$	1850.00		Obstruction Type			Storm Grate/Utility Type	
						N/A			N/A
