Access Compliance Report

Public Rights-of-Way

(Curb Ramps)

Intersection ID: 13679	Main Street: EUCLID_AV	Cross Street: LEXINGTON_AV	Location: W
ADA ID: 653B1F5534AF	Ramp Type: Perpendicular	Initial Pass/Fail: Fail	Overall Compliance: No
Severity Score: 1.25			
Codes/Mitigation Info/Possible Solution		Field Measurements/Component Compliance

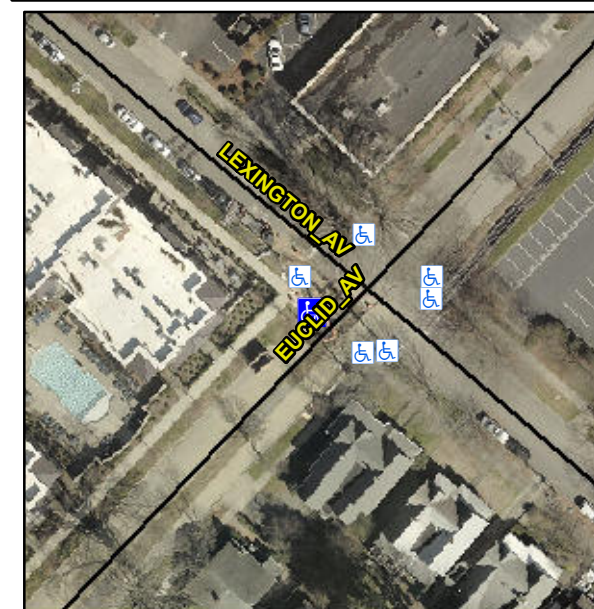
Compliance	Description	Data	Compliance	Description	Data
N/A	Ramp Length (in)	96.0	Yes	Ramp Slope (%)	6.8
Yes	Ramp Width (in)	68.0	No	Ramp XSlope (%)	3.3
N/A	Flare Type LT	N/A	N/A	Flare Type RT	N/A
N/A	Flare Slope LT (%)	N/A	N/A	Flare Slope RT (%)	N/A
N/A	Flare Traversable LT?	N/A	N/A	Flare Traversable RT?	N/A
N/A	Landing Length (in)	N/A	N/A	DWS Provided?	N/A
N/A	Landing Width (in)	N/A	N/A	DWS Contrast?	N/A
N/A	Landing Slope (%)	N/A	N/A	DWS Length (in)	N/A
N/A	Landing X Slope (%)	N/A	N/A	DWS Full Width?	N/A
N/A	Landing Curb? (Y/N)	N/A	N/A	DWS Offset (in)	N/A
N/A	Shared Landing?	N/A			
N/A	Gutter Ponding?	N/A	N/A	Gutter Slope (%)	N/A
N/A	Gutter Lip Ht (in)	N/A	N/A	Gutter X Slope (%)	N/A
N/A	Painted X Walk1?	No	N/A	Painted X Walk2?	N/A
	X Walk 1 Direction	To SE		X Walk 2 Direction	N/A
N/A	X Walk 1 Width (in)	N/A	N/A	X Walk 2 Width (in)	N/A
	X Walk 1 Slope (%)	0.1		X Walk 2 Slope (%)	N/A
	X Walk 1 X Slope (%)	1.5		X Walk 2 X Slope (%)	N/A

N/A	Ramp inside XWalk1?	N/A	N/A	Ramp inside XWalk2?	N/A
	Road Slope (%)	N/A	N/A	Clear Space?	N/A
	Road X Slope (%)	N/A	N/A	Clear Space to XWalk (in)	N/A
N/A	Any Obstructions?	N/A	N/A	Storm Grate/Utility Hazard?	N/A
	Obstruction Type			Storm Grate/Utility Type	
		N/A			N/A
		Yes		Surface Condition? (G/P)	Good

Possible Solutions:

Remove & Replace Entire Ramp.

PROW/ADA:

R304.5.3
