Access Compliance Report

Public Rights-of-Way

(Curb Ramps)

Intersection ID: 6766	Main Street: INDIAN RIDGE LN	Cross Street: WINDING CANYON DR	Location: S
ADA ID: 653C77A2D645	Ramp Type: Perpendicular Diagonal	Initial Pass/Fail: Fail	Overall Compliance: No
			Severity Score: 13.75

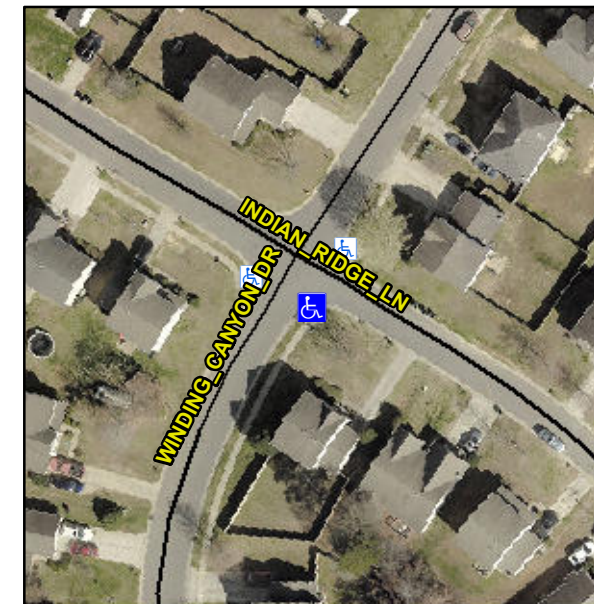
Not Found, R304.2.2, R304.5.3

Compliance	Description	Data	Compliance	Description	Data
N/A	Ramp Length (in)	49.5	No	Ramp Slope (%)	9.5
Yes	Ramp Width (in)	48.0	No	Ramp XSlope (%)	3.1
N/A	Flare Type LT	N/A	N/A	Flare Type RT	N/A
N/A	Flare Slope LT (%)	N/A	N/A	Flare Slope RT (%)	N/A
N/A	Flare Traversable LT?	N/A	N/A	Flare Traversable RT?	N/A
N/A	Landing Length (in)	N/A	N/A	DWS Provided?	N/A
N/A	Landing Width (in)	N/A	N/A	DWS Contrast?	N/A
N/A	Landing Slope (%)	N/A	N/A	DWS Length (in)	N/A
N/A	Landing X Slope (%)	N/A	N/A	DWS Full Width?	N/A
N/A	Landing Curb? (Y/N)	N/A	N/A	DWS Offset (in)	N/A
N/A	Shared Landing?	N/A			
N/A	Gutter Ponding?	N/A	N/A	Gutter Slope (%)	N/A
N/A	Gutter Lip Ht (in)	N/A	N/A	Gutter X Slope (%)	N/A
N/A	Painted X Walk1?	No	N/A	Painted X Walk2?	No
	X Walk 1 Direction	To NE		X Walk 2 Direction	To NW
N/A	X Walk 1 Width (in)	N/A	N/A	X Walk 2 Width (in)	N/A
	X Walk 1 Slope (%)	2.7		X Walk 2 Slope (%)	2.9
	X Walk 1 X Slope (%)	1.8		X Walk 2 X Slope (%)	2.0

N/A	Ramp inside XWalk1?	N/A	N/A	Ramp inside XWalk2?	N/A
	Road Slope (%)	1.8	N/A	Clear Space?	N/A
	Road X Slope (%)	1.5	N/A	Clear Space to XWalk (in)	N/A
N/A	Any Obstructions?	N/A	N/A	Storm Grate/Utility Hazard?	N/A
	Obstruction Type			Storm Grate/Utility Type	
		N/A			N/A
			Yes	Surface Condition? (G/P)	Good

Remove & Replace Curb Ramp With Two New Directional Ramps or Equivalent.

Total Cost: \$ 3200.00
