Access Compliance Report

Public Rights-of-Way

(Curb Ramps)

Intersection ID: 45539	Main Street: PEACHTREE_RD	Cross Street: CORVUS_CT	Location: SW
ADA ID: 65451792FD45	Ramp Type: Perpendicular Diagonal	Initial Pass/Fail: Fail	Overall Compliance: No
Severity Score: 10			
Codes/Mitigation Info/Possible Solution		Field Measurements/Component Compliance

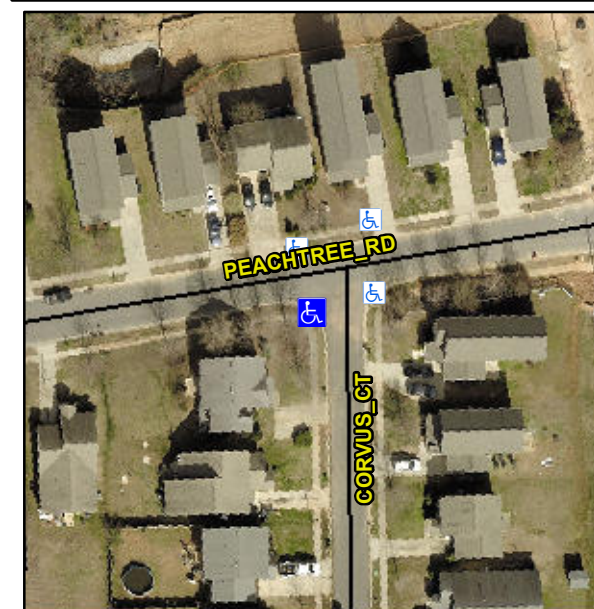
Not Found, R304.5.1, R304.5.3

Compliance	Description	Data	Compliance	Description	Data
N/A	Ramp Length (in)	48.0	Yes	Ramp Slope (%)	5.1
No	Ramp Width (in)	45.0	No	Ramp XSlope (%)	4.5
N/A	Flare Type LT	N/A	N/A	Flare Type RT	N/A
N/A	Flare Slope LT (%)	N/A	N/A	Flare Slope RT (%)	N/A
N/A	Flare Traversable LT?	N/A	N/A	Flare Traversable RT?	N/A
N/A	Landing Length (in)	N/A	N/A	DWS Provided?	N/A
N/A	Landing Width (in)	N/A	N/A	DWS Contrast?	N/A
N/A	Landing Slope (%)	N/A	N/A	DWS Length (in)	N/A
N/A	Landing X Slope (%)	N/A	N/A	DWS Full Width?	N/A
N/A	Landing Curb? (Y/N)	N/A	N/A	DWS Offset (in)	N/A
N/A	Shared Landing?	N/A			
N/A	Gutter Ponding?	N/A	N/A	Gutter Slope (%)	N/A
N/A	Gutter Lip Ht (in)	N/A	N/A	Gutter X Slope (%)	N/A
N/A	Painted X Walk1?	No	N/A	Painted X Walk2?	No
	X Walk 1 Direction	To E		X Walk 2 Direction	To N
N/A	X Walk 1 Width (in)	N/A	N/A	X Walk 2 Width (in)	N/A
	X Walk 1 Slope (%)	1.5		X Walk 2 Slope (%)	2.7
	X Walk 1 X Slope (%)	0.7		X Walk 2 X Slope (%)	2.3

N/A	Ramp inside XWalk1?	N/A	N/A	Ramp inside XWalk2?	N/A
	Road Slope (%)	2.7	N/A	Clear Space?	N/A
	Road X Slope (%)	4.9	N/A	Clear Space to XWalk (in)	N/A
N/A	Any Obstructions?	N/A	N/A	Storm Grate/Utility Hazard?	N/A
	Obstruction Type			Storm Grate/Utility Type	
		N/A			N/A
			Yes	Surface Condition? (G/P)	Good

Remove & Replace Curb Ramp With Two New Directional Ramps or Equivalent.
