Access Compliance Report

Public Rights-of-Way

(Curb Ramps)

Intersection ID: 19931	Main Street: CARNEGIE_BV	Cross Street: ASSEMBLY ST	Location: SW
ADA ID: 65476D61C8CB	Ramp Type: Perp	Initial Pass/Fail: Fail	Overall Compliance: No
Severity Score: 1.25			
Codes/Mitigation Info/Possible Solution		Field Measurements/Component Compliance

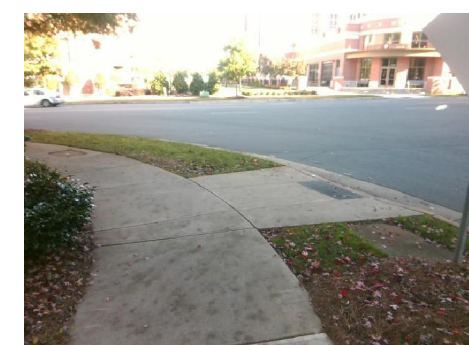
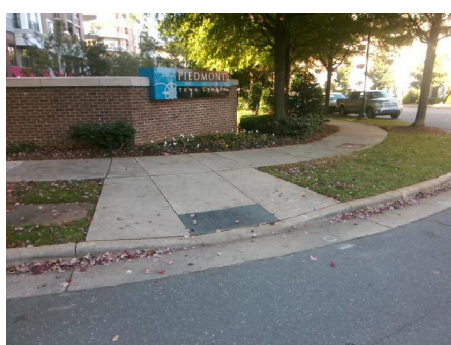
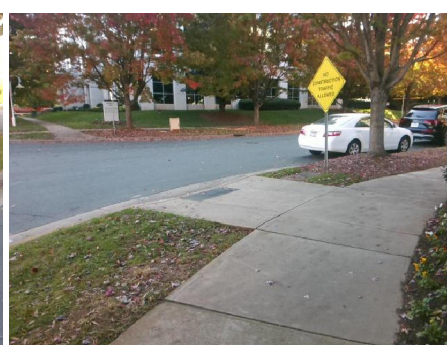
Not Found, R304.5.3

Compliance	Description	Data	Compliance	Description	Data
N/A	Ramp Length (in)	96.0	Yes	Ramp Slope (%)	7.3
Yes	Ramp Width (in)	48.0	No	Ramp XSlope (%)	3.8
N/A	Flare Type LT	N/A	N/A	Flare Type RT	N/A
N/A	Flare Slope LT (%)	N/A	N/A	Flare Slope RT (%)	N/A
N/A	Flare Traversable LT?	N/A	N/A	Flare Traversable RT?	N/A
N/A	Landing Length (in)	N/A	N/A	DWS Provided?	N/A
N/A	Landing Width (in)	N/A	N/A	DWS Contrast?	N/A
N/A	Landing Slope (%)	N/A	N/A	DWS Length (in)	N/A
N/A	Landing X Slope (%)	N/A	N/A	DWS Full Width?	N/A
N/A	Landing Curb? (Y/N)	N/A	N/A	DWS Offset (in)	N/A
N/A	Shared Landing?	N/A			
N/A	Gutter Ponding?	N/A	N/A	Gutter Slope (%)	N/A
N/A	Gutter Lip Ht (in)	N/A	N/A	Gutter X Slope (%)	N/A
N/A	Painted X Walk1?	No	N/A	Painted X Walk2?	N/A
	X Walk 1 Direction	To E		X Walk 2 Direction	N/A
N/A	X Walk 1 Width (in)	N/A	N/A	X Walk 2 Width (in)	N/A
	X Walk 1 Slope (%)	3.4		X Walk 2 Slope (%)	N/A
	X Walk 1 X Slope (%)	2.2		X Walk 2 X Slope (%)	N/A

N/A	Ramp inside XWalk1?	N/A	N/A	Ramp inside XWalk2?	N/A
	Road Slope (%)	N/A	N/A	Clear Space?	N/A
	Road X Slope (%)	N/A	N/A	Clear Space to XWalk (in)	N/A
N/A	Any Obstructions?	N/A	N/A	Storm Grate/Utility Hazard?	N/A
	Obstruction Type			Storm Grate/Utility Type	
		N/A			N/A
			Yes	Surface Condition? (G/P)	Good

Possible Solutions:

Remove & Replace Entire Ramp.
