Access Compliance Report

Public Rights-of-Way

(Curb Ramps)

Intersection ID: N/A	Main Street: LANGWELL_LN	Cross Street: INVERNESS_BAY_RD	Location: SW
ADA ID: 6549B298BDCD	Ramp Type: Perp	Initial Pass/Fail: Fail	Overall Compliance: No
Severity Score: 33.75			
Codes/Mitigation Info/Possible Solution		Field Measurements/Component Compliance

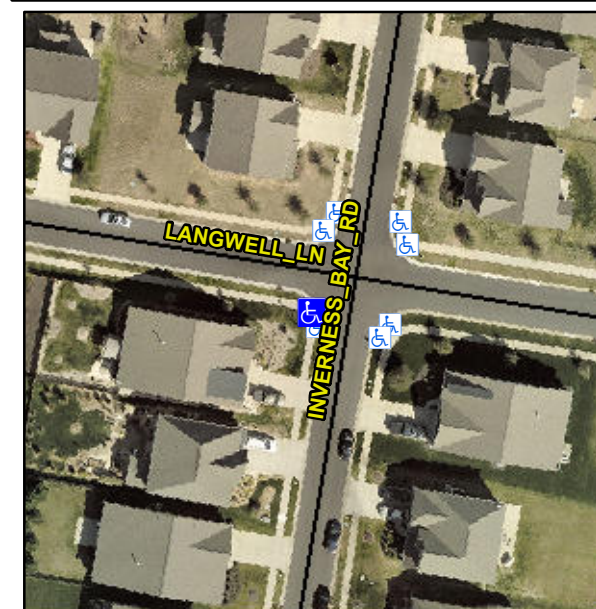
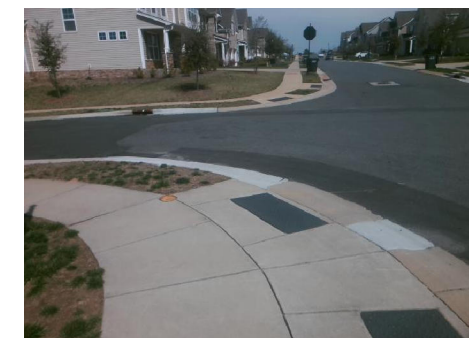
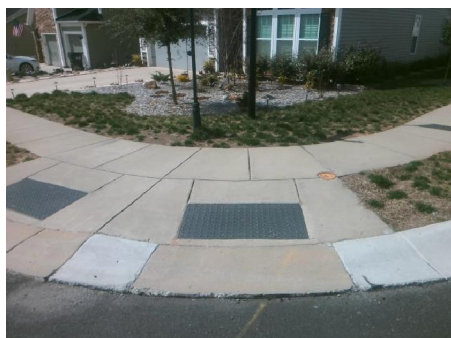
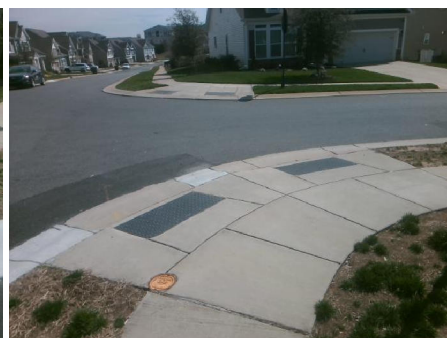
R304.5.1, R304.2.2, R304.5.3

Compliance	Description	Data	Compliance	Description	Data
N/A	Ramp Length (in)	48.5	No	Ramp Slope (%)	8.5
No	Ramp Width (in)	47.0	No	Ramp XSlope (%)	5.2
N/A	Flare Type LT	N/A	N/A	Flare Type RT	N/A
N/A	Flare Slope LT (%)	N/A	N/A	Flare Slope RT (%)	N/A
N/A	Flare Traversable LT?	N/A	N/A	Flare Traversable RT?	N/A
N/A	Landing Length (in)	N/A	N/A	DWS Provided?	N/A
N/A	Landing Width (in)	N/A	N/A	DWS Contrast?	N/A
N/A	Landing Slope (%)	N/A	N/A	DWS Length (in)	N/A
N/A	Landing X Slope (%)	N/A	N/A	DWS Full Width?	N/A
N/A	Landing Curb? (Y/N)	N/A	N/A	DWS Offset (in)	N/A
N/A	Shared Landing?	N/A			
N/A	Gutter Ponding?	N/A	N/A	Gutter Slope (%)	N/A
N/A	Gutter Lip Ht (in)	1.0	N/A	Gutter X Slope (%)	N/A
N/A	Painted X Walk1?	No	N/A	Painted X Walk2?	N/A
	X Walk 1 Direction	To NE		X Walk 2 Direction	N/A
N/A	X Walk 1 Width (in)	N/A	N/A	X Walk 2 Width (in)	N/A
	X Walk 1 Slope (%)	2.2		X Walk 2 Slope (%)	N/A
	X Walk 1 X Slope (%)	1.3		X Walk 2 X Slope (%)	N/A

N/A	Ramp inside XWalk1?	N/A	N/A	Ramp inside XWalk2?	N/A
	Road Slope (%)	N/A	N/A	Clear Space?	N/A
	Road X Slope (%)	N/A	N/A	Clear Space to XWalk (in)	N/A
N/A	Any Obstructions?	N/A	N/A	Storm Grate/Utility Hazard?	N/A
	Obstruction Type			Storm Grate/Utility Type	
		N/A			N/A
			Yes	Surface Condition? (G/P)	Good

Possible Solutions:

Remove & Replace Entire Ramp.

Total Cost: \$ 1850.00
