Access Compliance Report Public Rights-of-Way (Curb Ramps)

Intersection ID: 30265 Main Street: FORTESCUE DR Cross Street: W_ROCKY_RIVER_RD Location: ADA ID: 65529F2BADAD Ramp Type: Perpendicular Initial Pass/Fail: Fail **Overall Compliance: No** Severity Score: 46.25

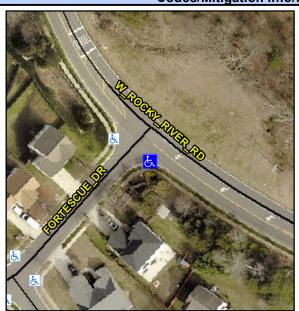
FORTESCUE DR Street 1 Name Stop Condition-Street 2 StopSign Street 2 Name N/A Stop Condition-Street 1 N/A Possible Solutions: Remove & Replace Entire Ramp. Surveyor Notes: N/A PROW/ADA: R304.5.1, R304.2.2, R304.5.3
