# Access Compliance Report

## Public Rights-of-Way

| Intersection ID: 8835 | Main Street: BRADFORD_DR | Cross Street: N/A | Location: W |
| ADA ID: 655452ED5F50 | Ramp Type: BlendTrans2 | Initial Pass/Fail: Fail | Overall Compliance: No |

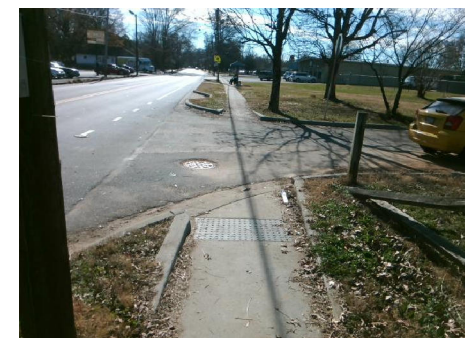
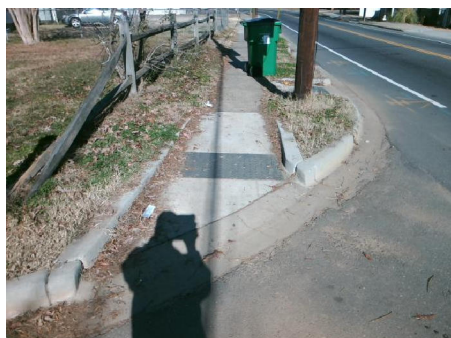
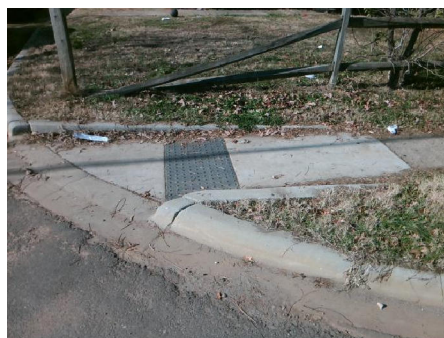
**Not Found, R304.5.3**

| Compliance | Description | Data | Compliance | Description | Data |
|---|---|---|---|---|---|
| Yes | Ramp Width (in) | 48.0 | No | BlendTrans XSlope (%) | 3.9 |
| | | | No | Curb Slope (%) | 11.0 |

**Remove & Replace Curb Ramp With Two New Directional Ramps or Equivalent.**
