# Access Compliance Report

## Public Rights-of-Way

### (Curb Ramps)

Intersection ID: 20325	Main Street: CREOLA_RD	Cross Street: PROVIDENCE_RD	Location: SW
ADA ID: 655D84B18C96	Ramp Type: Perpendicular Diagonal	Initial Pass/Fail: Fail	Overall Compliance: No
		Severity Score: 12.5

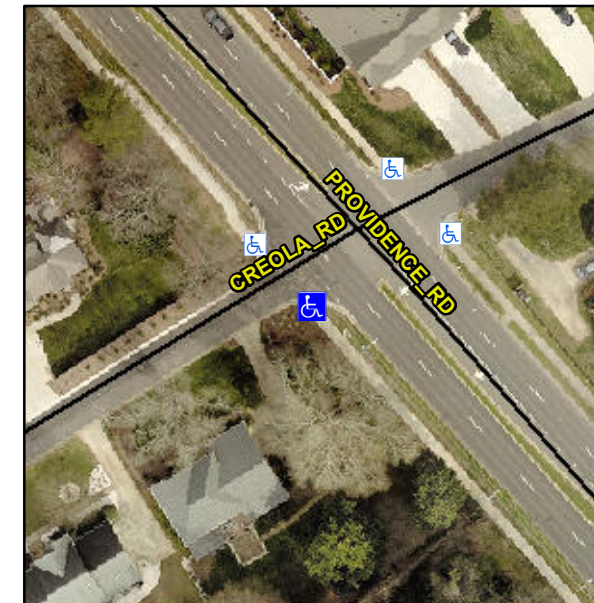
Compliance	Description	Data	Compliance	Description	Data
N/A	Ramp Length (in)	74.0	No	Ramp Slope (%)	9.6
Yes	Ramp Width (in)	94.0	Yes	Ramp XSlope (%)	1.1
N/A	Flare Type LT	N/A	N/A	Flare Type RT	N/A
N/A	Flare Slope LT (%)	N/A	N/A	Flare Slope RT (%)	N/A
N/A	Flare Traversable LT?	N/A	N/A	Flare Traversable RT?	N/A
N/A	Landing Length (in)	N/A	N/A	DWS Provided?	N/A
N/A	Landing Width (in)	N/A	N/A	DWS Contrast?	N/A
N/A	Landing Slope (%)	N/A	N/A	DWS Length (in)	N/A
N/A	Landing X Slope (%)	N/A	N/A	DWS Full Width?	N/A
N/A	Landing Curb? (Y/N)	N/A	N/A	DWS Offset (in)	N/A
N/A	Shared Landing?	N/A			
N/A	Gutter Ponding?	N/A	N/A	Gutter Slope (%)	N/A
N/A	Gutter Lip Ht (in)	N/A	N/A	Gutter X Slope (%)	N/A
N/A	Painted X Walk1?	No	N/A	Painted X Walk2?	No
	X Walk 1 Direction	To NE		X Walk 2 Direction	To NW
N/A	X Walk 1 Width (in)	N/A	N/A	X Walk 2 Width (in)	N/A
	X Walk 1 Slope (%)	0.8		X Walk 2 Slope (%)	4.4
	X Walk 1 X Slope (%)	2.6		X Walk 2 X Slope (%)	1.0

N/A	Ramp inside XWalk1?	N/A	N/A	Ramp inside XWalk2?	N/A
	Road Slope (%)	3.3	N/A	Clear Space?	N/A
	Road X Slope (%)	2.0	N/A	Clear Space to XWalk (in)	N/A
N/A	Any Obstructions?	N/A	N/A	Storm Grate/Utility Hazard?	N/A
	Obstruction Type			Storm Grate/Utility Type	
		N/A			N/A
			Yes	Surface Condition? (G/P)	Good

**Remove & Replace Curb Ramp With Two New Directional Ramps or Equivalent.**

**R304.2.2**
