# Access Compliance Report

## Public Rights-of-Way

### (Curb Ramps)

| Intersection ID: 21209 | Main Street: GALLERIA_BV | Cross Street: SARDIS_RD_NORTH | Location: NE |

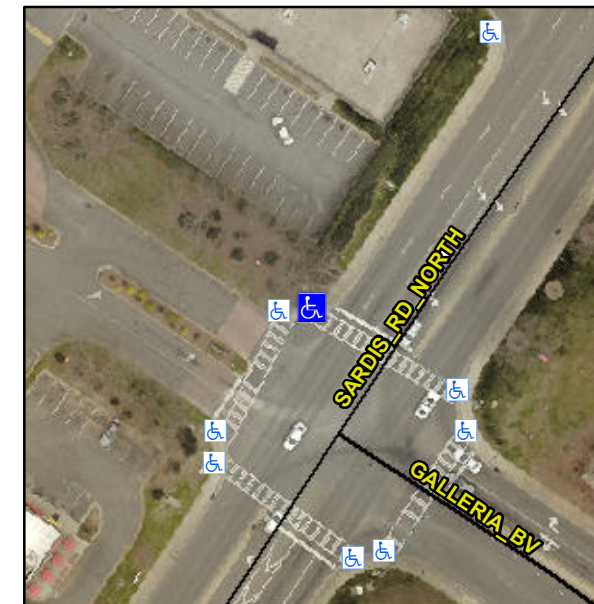
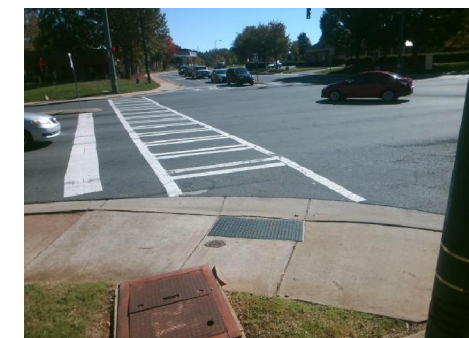
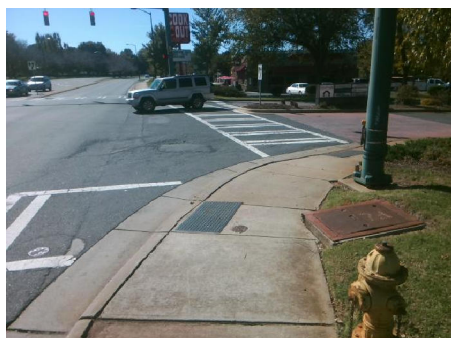
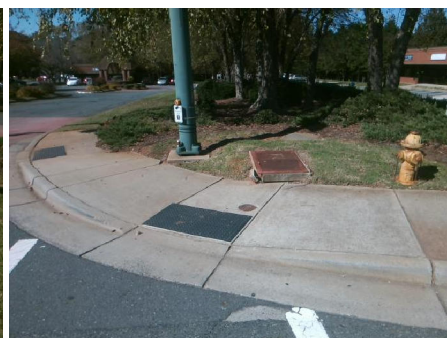
| ADA ID: 6561864F4F7F | Ramp Type: Perpendicular | Initial Pass/Fail: Fail | Overall Compliance: No |

**Not Found, R304.5.1, R304.2.2, R304.5.3**

| Compliance | Description | Data | Compliance | Description | Data |
|---|---|---|---|---|---|
| N/A | Ramp Length (in) | 72.0 | No | Ramp Slope (%) | 8.6 |
| No | Ramp Width (in) | 39.0 | No | Ramp XSlope (%) | 5.2 |

**Remove & Replace Entire Ramp.**
