## **Access Compliance Report Public Rights-of-Way** (Curb Ramps)

Intersection ID: N/A Main Street: SOUTHSTREAM BV Cross Street: N/A SE Location: Initial Pass/Fail: Fail **Overall Compliance: No** Severity Score: 46.25 ADA ID: 658181409A46 Ramp Type: Perpendicular Diagonal

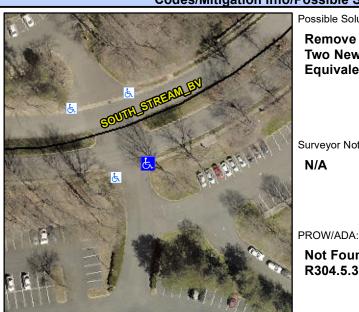
Not Found, R304.5.1, R304.2.2, R304.5.3

Total Cost: 3200.00 Compliance Description Data Compliance Description Data No Ramp Length (in) 35.0 Ramp Slope (%) 11.9 No Ramp XSlope (%) Ramp Width (in) 39.0 9.4 N/A Flare Type LT N/A Flare Type RT N/A Flare Slope LT (%) N/A N/A Flare Slope RT (%) N/A Flare Traversable LT? Nο N/A Flare Traversable RT? No Landing Length (in) N/A N/A **DWS Provided?** N/A Landing Width (in) N/A N/A **DWS Contrast?** N/A N/A N/A Landing Slope (%) DWS Length (in) N/A Landing X Slope (%) N/A N/A DWS Full Width? N/A Landing Curb? (Y/N) N/A N/A DWS Offset (in) N/A N/A Shared Landing? **Gutter Ponding?** N/A N/A Gutter Slope (%) N/A Gutter Lip Ht (in) N/A N/A Gutter X Slope (%) N/A Painted X Walk1? No N/A Painted X Walk2? No X Walk 1 Direction To N X Walk 2 Direction To W N/A X Walk 1 Width (in) X Walk 2 Width (in) N/A X Walk 1 Slope (%) 3.3 X Walk 2 Slope (%) 5.8 X Walk 1 X Slope (%) 5.8 X Walk 2 X Slope (%) 0.5 N/A N/A N/A Ramp inside XWalk2? N/A Ramp inside XWalk1? Road Slope (%) 5.1 N/A Clear Space? N/A N/A Road X Slope (%) 5.8 Clear Space to XWalk (in) N/A N/A N/A N/A Any Obstructions? Storm Grate/Utility Hazard? N/A **Obstruction Type** Storm Grate/Utility Type N/A N/A Yes Surface Condition? (G/P) Good

Possible Solutions: Remove & Replace Curb Ramp With Two New Directional Ramps or Equivalent. Surveyor Notes: N/A
