Access Compliance Report

Public Rights-of-Way

(Curb Ramps)

Intersection ID: 7966	Main Street: PAWTUCKETT_RD	Cross Street: SWIFT_ARROW_LN	Location: S
ADA ID: 65821454D1C6	Ramp Type: Perpendicular	Initial Pass/Fail: Fail	Overall Compliance: No
Severity Score: 12.5			
Codes/Mitigation Info/Possible Solution		Field Measurements/Component Compliance

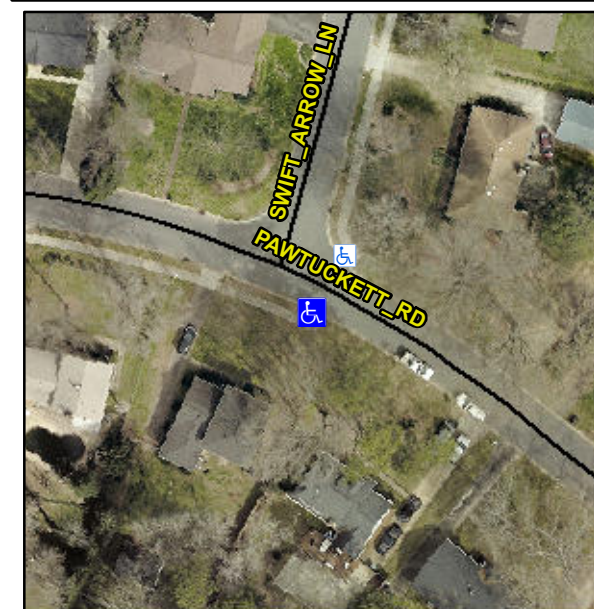
Not Found, R304.2.2

Compliance	Description	Data	Compliance	Description	Data
N/A	Ramp Length (in)	48.0	No	Ramp Slope (%)	8.8
Yes	Ramp Width (in)	48.0	Yes	Ramp XSlope (%)	1.8
N/A	Flare Type LT	N/A	N/A	Flare Type RT	N/A
N/A	Flare Slope LT (%)	N/A	N/A	Flare Slope RT (%)	N/A
N/A	Flare Traversable LT?	N/A	N/A	Flare Traversable RT?	N/A
N/A	Landing Length (in)	N/A	N/A	DWS Provided?	N/A
N/A	Landing Width (in)	N/A	N/A	DWS Contrast?	N/A
N/A	Landing Slope (%)	N/A	N/A	DWS Length (in)	N/A
N/A	Landing X Slope (%)	N/A	N/A	DWS Full Width?	N/A
N/A	Landing Curb? (Y/N)	N/A	N/A	DWS Offset (in)	N/A
N/A	Shared Landing?	N/A			
N/A	Gutter Ponding?	N/A	N/A	Gutter Slope (%)	N/A
N/A	Gutter Lip Ht (in)	N/A	N/A	Gutter X Slope (%)	N/A
N/A	Painted X Walk1?	No	N/A	Painted X Walk2?	N/A
	X Walk 1 Direction	To NE		X Walk 2 Direction	N/A
N/A	X Walk 1 Width (in)	N/A	N/A	X Walk 2 Width (in)	N/A
	X Walk 1 Slope (%)	1.8		X Walk 2 Slope (%)	N/A
	X Walk 1 X Slope (%)	7.4		X Walk 2 X Slope (%)	N/A

N/A	Ramp inside XWalk1?	N/A	N/A	Ramp inside XWalk2?	N/A
	Road Slope (%)	N/A	N/A	Clear Space?	N/A
	Road X Slope (%)	N/A	N/A	Clear Space to XWalk (in)	N/A
N/A	Any Obstructions?	N/A	N/A	Storm Grate/Utility Hazard?	N/A
	Obstruction Type			Storm Grate/Utility Type	
		N/A			N/A
			Yes	Surface Condition? (G/P)	Good

Possible Solutions:

Remove & Replace Entire Ramp.
