Access Compliance Report

Public Rights-of-Way

(Curb Ramps)

Intersection ID: 16819	Main Street: SOUTHSIDE_DR	Cross Street: OLD_PINEVILLE_RD	Location: NW
ADA ID: 659DB3391ACF	Ramp Type: Perpendicular Diagonal	Initial Pass/Fail: Fail	Overall Compliance: No
		Severity Score: 12.5

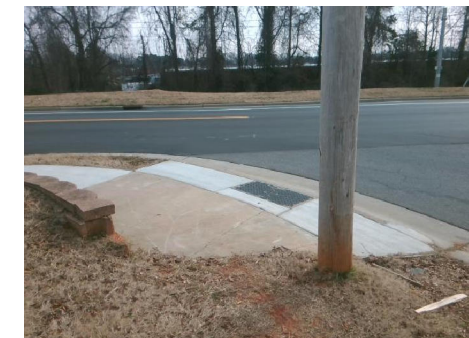
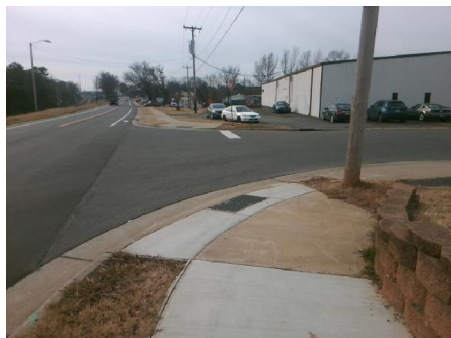
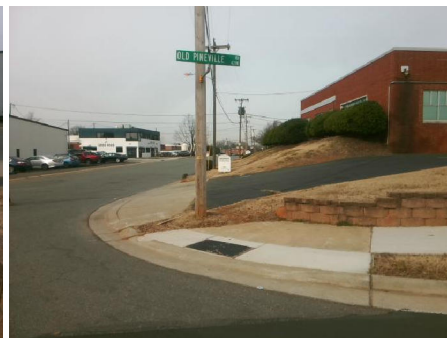
Compliance	Description	Data	Compliance	Description	Data
N/A	Ramp Length (in)	36.0	Yes	Ramp Slope (%)	7.0
Yes	Ramp Width (in)	48.0	No	Ramp XSlope (%)	5.2
N/A	Flare Type LT	N/A	N/A	Flare Type RT	N/A
N/A	Flare Slope LT (%)	N/A	N/A	Flare Slope RT (%)	N/A
N/A	Flare Traversable LT?	N/A	N/A	Flare Traversable RT?	N/A
N/A	Landing Length (in)	N/A	N/A	DWS Provided?	N/A
N/A	Landing Width (in)	N/A	N/A	DWS Contrast?	N/A
N/A	Landing Slope (%)	N/A	N/A	DWS Length (in)	N/A
N/A	Landing X Slope (%)	N/A	N/A	DWS Full Width?	N/A
N/A	Landing Curb? (Y/N)	N/A	N/A	DWS Offset (in)	N/A
N/A	Shared Landing?	N/A			
N/A	Gutter Ponding?	N/A	N/A	Gutter Slope (%)	N/A
N/A	Gutter Lip Ht (in)	N/A	N/A	Gutter X Slope (%)	N/A
N/A	Painted X Walk1?	No	N/A	Painted X Walk2?	No
	X Walk 1 Direction	To SW		X Walk 2 Direction	To E
N/A	X Walk 1 Width (in)	N/A	N/A	X Walk 2 Width (in)	N/A
	X Walk 1 Slope (%)	0.1		X Walk 2 Slope (%)	0.5
	X Walk 1 X Slope (%)	2.1		X Walk 2 X Slope (%)	0.5

N/A	Ramp inside XWalk1?	N/A	N/A	Ramp inside XWalk2?	N/A
	Road Slope (%)	4.7	N/A	Clear Space?	N/A
	Road X Slope (%)	1.2	N/A	Clear Space to XWalk (in)	N/A
N/A	Any Obstructions?	N/A	N/A	Storm Grate/Utility Hazard?	N/A
	Obstruction Type			Storm Grate/Utility Type	
		N/A			N/A
			Yes	Surface Condition? (G/P)	Good

Possible Solutions:

Remove & Replace Curb Ramp With Two New Directional Ramps or Equivalent.
