Access Compliance Report

Public Rights-of-Way

(Curb Ramps)

Intersection ID: 13754		Main Street: S_MCDOWELL_ST		Cross Street: BAXTER_ST		Location: NE			
ADA ID: 65A0011D1166		Ramp Type: Perpendicular		Initial Pass/Fail: Fail		Overall Compliance: No		Severity Score: 37.5	
Codes/Mitigation Info/Possible Solution					Field Measurements/Component Compliance

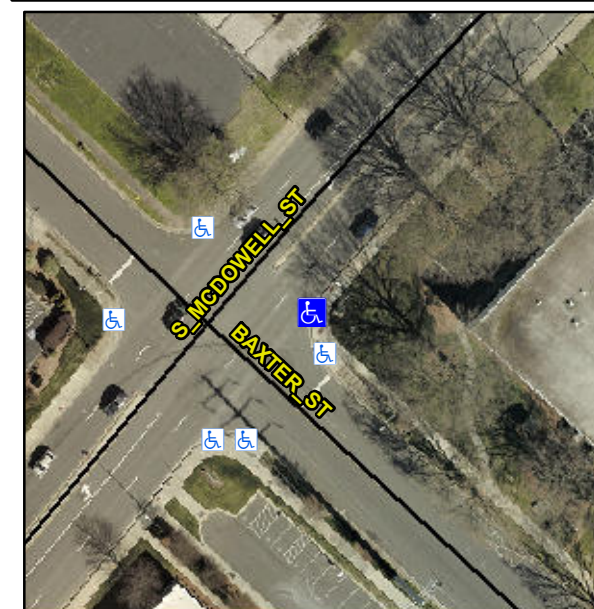
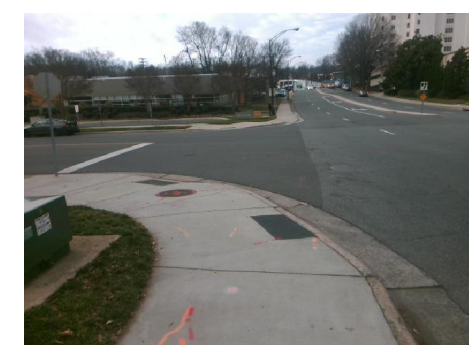
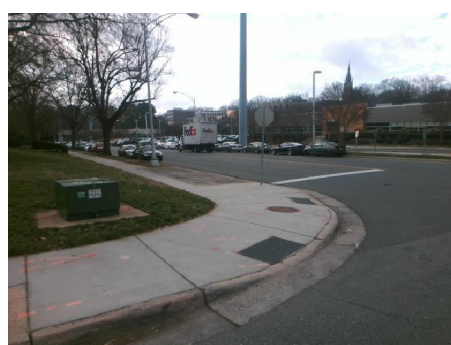
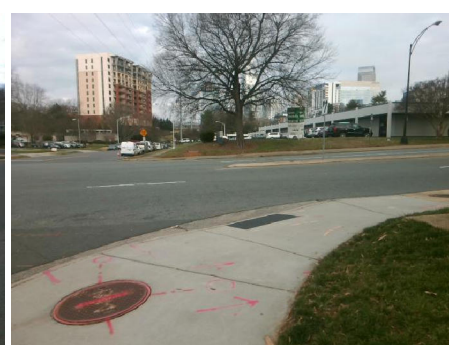
Not Found, R304.2.2, R304.5.3

Compliance	Description	Data	Compliance	Description	Data
N/A	Ramp Length (in)	86.0	No	Ramp Slope (%)	9.8
Yes	Ramp Width (in)	48.0	No	Ramp XSlope (%)	9.4
N/A	Flare Type LT	N/A	N/A	Flare Type RT	N/A
N/A	Flare Slope LT (%)	N/A	N/A	Flare Slope RT (%)	N/A
N/A	Flare Traversable LT?	N/A	N/A	Flare Traversable RT?	N/A
N/A	Landing Length (in)	N/A	N/A	DWS Provided?	N/A
N/A	Landing Width (in)	N/A	N/A	DWS Contrast?	N/A
N/A	Landing Slope (%)	N/A	N/A	DWS Length (in)	N/A
N/A	Landing X Slope (%)	N/A	N/A	DWS Full Width?	N/A
N/A	Landing Curb? (Y/N)	N/A	N/A	DWS Offset (in)	N/A
N/A	Shared Landing?	N/A			
N/A	Gutter Ponding?	N/A	N/A	Gutter Slope (%)	N/A
N/A	Gutter Lip Ht (in)	N/A	N/A	Gutter X Slope (%)	N/A
N/A	Painted X Walk1?	No	N/A	Painted X Walk2?	N/A
	X Walk 1 Direction	To NW		X Walk 2 Direction	N/A
N/A	X Walk 1 Width (in)	N/A	N/A	X Walk 2 Width (in)	N/A
	X Walk 1 Slope (%)	3.6		X Walk 2 Slope (%)	N/A
	X Walk 1 X Slope (%)	2.5		X Walk 2 X Slope (%)	N/A

N/A	Ramp inside XWalk1?	N/A	N/A	Ramp inside XWalk2?	N/A
	Road Slope (%)	N/A	N/A	Clear Space?	N/A
	Road X Slope (%)	N/A	N/A	Clear Space to XWalk (in)	N/A
N/A	Any Obstructions?	N/A	N/A	Storm Grate/Utility Hazard?	N/A
	Obstruction Type			Storm Grate/Utility Type	
		N/A			N/A
			Yes	Surface Condition? (G/P)	Good

Remove & Replace Entire Ramp.
