Access Compliance Report Public Rights-of-Way (Curb Ramps)

Intersection ID: 23851 Main Street: BOLINGBROOK LN **Cross Street: CARTGATE LN** Location: NE **Overall Compliance: No Severity Score:** 12.5 ADA ID: 65AE33B88A64 Ramp Type: Perpendicular Diagonal Initial Pass/Fail: Fail

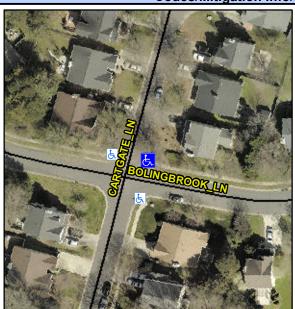
No Ramp Length (in) 96.0 Ramp Slope (%) 8.7 Yes Ramp XSlope (%) Ramp Width (in) 48.0 0.2 N/A Flare Type LT N/A Flare Type RT N/A N/A N/A Flare Slope RT (%) N/A Flare Slope LT (%) Flare Traversable LT? N/A N/A Flare Traversable RT? N/A N/A N/A DWS Provided? N/A Landing Length (in) Landing Width (in) N/A N/A **DWS Contrast?** N/A N/A N/A Landing Slope (%) DWS Length (in) N/A Landing X Slope (%) N/A N/A DWS Full Width? N/A Landing Curb? (Y/N) N/A N/A DWS Offset (in) N/A N/A Shared Landing? **Gutter Ponding?** N/A N/A Gutter Slope (%) N/A Gutter Lip Ht (in) N/A N/A Gutter X Slope (%) N/A Painted X Walk1? No N/A Painted X Walk2? No X Walk 1 Direction To NW X Walk 2 Direction To SW N/A X Walk 1 Width (in) X Walk 2 Width (in) N/A X Walk 1 Slope (%) 0.8 X Walk 2 Slope (%) 2.1 X Walk 1 X Slope (%) 2.8 X Walk 2 X Slope (%) 0.0 N/A N/A Ramp inside XWalk2? N/A Ramp inside XWalk1? Road Slope (%) 1.7 N/A Clear Space? N/A N/A Road X Slope (%) 1.9 Clear Space to XWalk (in) N/A N/A N/A Any Obstructions? Storm Grate/Utility Hazard? N/A **Obstruction Type** Storm Grate/Utility Type N/A N/A Yes Surface Condition? (G/P) Good

CARTGATE LN Street 1 Name Stop Condition-Street 2 StopSign **BOILINGBROOK LN** Street 2 Name Stop Condition-Street 1 None Possible Solutions: Remove & Replace Curb Ramp With Two New Directional Ramps or Equivalent. Surveyor Notes: N/A PROW/ADA: R304.2.2
