Access Compliance Report

Public Rights-of-Way

(Curb Ramps)

Intersection ID: 10037852		Main Street: SHARON_RD		Cross Street: N/A		Location:		NE									
ADA ID: 65B9667AB811		Ramp Type: Directional1		Initial Pass/Fail: Fail		Overall Compliance: No		Severity Score: 25									
Codes/Mitigation Info/Possible Solution				Field Measurements/Component Compliance													
<div>

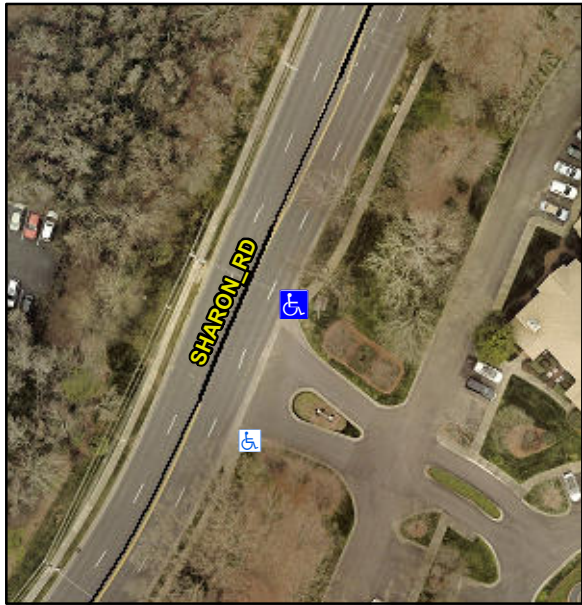
</div> <div>Street 1 NameENTRANCE</div> <div>Stop Condition-Street 1StopSign</div> <div>Street 2 NameN/A</div> <div>Stop Condition-Street 2N/A</div> <div>Possible Solutions: Remove & Replace Entire Ramp.</div> <div>Surveyor Notes: N/A</div> <div>PROW/ADA: R304.5.3</div> <div>Total Cost: \$ 1600.00</div>				Compliance		Description		Data		Compliance		Description		Data			
				N/A		Ramp Length (in)		50.0		N/A		Grade Break?		N/A		N/A	
				Yes		Ramp Width (in)		64.0		N/A		Grade Break Slope (%)		N/A		0.0	
				Yes		Ramp Slope (%)		6.3		N/A		Grade Break XSlope (%)		N/A		0.0	
				No		Ramp XSlope (%)		13.5

N/A		Flare Type LT		N/A		N/A		Flare Type RT		N/A		N/A	
				N/A		Flare Slope LT (%)		N/A		N/A		Flare Slope RT (%)		N/A		0.0	
				N/A		Flare Traversable LT?		N/A		N/A		Flare Traversable RT?		N/A		N/A	
				N/A		Landing Length (in)		0.0		N/A		DWS Provided?		N/A		N/A	
				N/A		Landing Width (in)		0.0		N/A		DWS Contrast?		N/A		N/A	
				N/A		Landing Slope (%)		0.0		N/A		DWS Length (in)		N/A		N/A	
				N/A		Landing X Slope (%)		0.0		N/A		DWS Full Width?		N/A		N/A	
				N/A		Landing Curb? (Y/N)		N/A		N/A		DWS Offset LT (in)		N/A		N/A	
				N/A		Shared Landing?		N/A		N/A		DWS Offset RT (in)		N/A		N/A	
				N/A		Gutter Ponding?		0.0		N/A		Gutter Slope (%)		N/A		N/A	
				N/A		Gutter Lip Ht (in)		0.0		N/A		Gutter X Slope (%)		N/A		N/A	
				N/A		Painted X Walk1?		No				Road Slope (%)				1.6	
						X Walk 1 Direction		To S				Road X Slope (%)				2.6	
						X Walk 1 Width (in)		N/A				Clear Space?				N/A	
						X Walk 1 Slope (%)		1.6		N/A		Clear Space to XWalk (in)		N/A		N/A

X Walk 1 X Slope (%)		2.6		N/A		Storm Grate/Utility Hazard?		N/A		N/A	
				N/A		Ramp inside XWalk1?		N/A				Storm Grate/Utility Type					
				N/A		Any Obstructions?		N/A								N/A	
						Obstruction Type				Yes		Surface Condition? (G/P)		Good			
										N/A		N/A		Curb Slope (%)		2.4
