# Access Compliance Report

## Public Rights-of-Way

### (Curb Ramps)

Intersection ID: 17908	Main Street: CHENANGO_DR	Cross Street: IDLEWILD_RD	Location: SW
ADA ID: 65CAE04A878B	Ramp Type: Perpendicular Diagonal	Initial Pass/Fail: Fail	Overall Compliance: No
Codes/Mitigation Info/Possible Solution			Severity Score: 13.75
			Field Measurements/Component Compliance

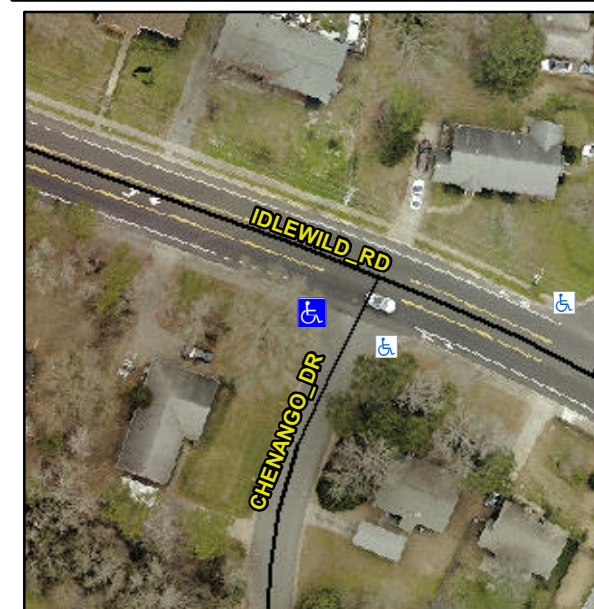
**Not Found, R304.2.2, R304.5.3**

Compliance	Description	Data	Compliance	Description	Data
N/A	Ramp Length (in)	60.0	No	Ramp Slope (%)	9.6
Yes	Ramp Width (in)	48.0	No	Ramp XSlope (%)	4.6
N/A	Flare Type LT	N/A	N/A	Flare Type RT	N/A
N/A	Flare Slope LT (%)	N/A	N/A	Flare Slope RT (%)	N/A
N/A	Flare Traversable LT?	N/A	N/A	Flare Traversable RT?	N/A
N/A	Landing Length (in)	N/A	N/A	DWS Provided?	N/A
N/A	Landing Width (in)	N/A	N/A	DWS Contrast?	N/A
N/A	Landing Slope (%)	N/A	N/A	DWS Length (in)	N/A
N/A	Landing X Slope (%)	N/A	N/A	DWS Full Width?	N/A
N/A	Landing Curb? (Y/N)	N/A	N/A	DWS Offset (in)	N/A
N/A	Shared Landing?	N/A			
N/A	Gutter Ponding?	N/A	N/A	Gutter Slope (%)	N/A
N/A	Gutter Lip Ht (in)	1.0	N/A	Gutter X Slope (%)	N/A
N/A	Painted X Walk1?	No	N/A	Painted X Walk2?	No
	X Walk 1 Direction	To SE		X Walk 2 Direction	To NE
N/A	X Walk 1 Width (in)	N/A	N/A	X Walk 2 Width (in)	N/A
	X Walk 1 Slope (%)	0.1		X Walk 2 Slope (%)	4.4
	X Walk 1 X Slope (%)	3.3		X Walk 2 X Slope (%)	1.3

N/A	Ramp inside XWalk1?	N/A	N/A	Ramp inside XWalk2?	N/A
	Road Slope (%)	3.4	N/A	Clear Space?	N/A
	Road X Slope (%)	3.8	N/A	Clear Space to XWalk (in)	N/A
N/A	Any Obstructions?	N/A	N/A	Storm Grate/Utility Hazard?	N/A
	Obstruction Type			Storm Grate/Utility Type	
		N/A			N/A
			Yes	Surface Condition? (G/P)	Good

**Remove & Replace Curb Ramp With Two New Directional Ramps or Equivalent.**

Total Cost: \$ 3200.00
