# Access Compliance Report

## Public Rights-of-Way

### (Curb Ramps)

Intersection ID: 28109	Main Street: BLAKENEY_HEATH_RD	Cross Street: BORCHETTA_DR	Location:	N
ADA ID: 65E66068263A	Ramp Type: Perpendicular Diagonal	Initial Pass/Fail: Fail	Overall Compliance: No	Severity Score: 12.5

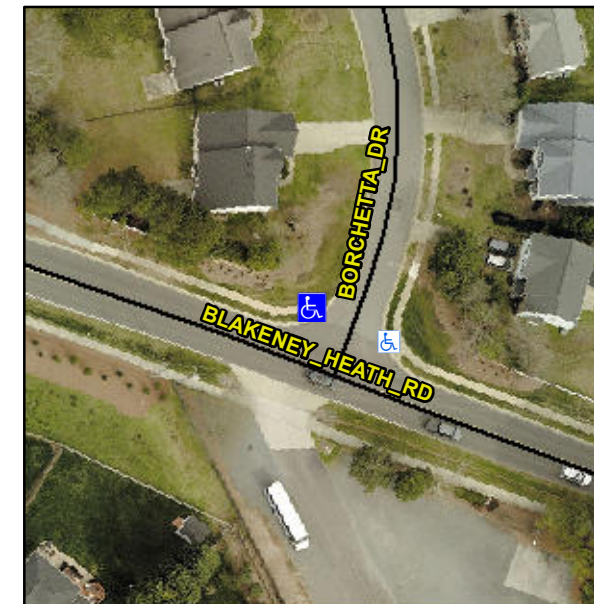
Compliance	Description	Data	Compliance	Description	Data
N/A	Ramp Length (in)	97.0	Yes	Ramp Slope (%)	7.2
Yes	Ramp Width (in)	48.0	No	Ramp XSlope (%)	5.8
N/A	Flare Type LT	N/A	N/A	Flare Type RT	N/A
N/A	Flare Slope LT (%)	N/A	N/A	Flare Slope RT (%)	N/A
N/A	Flare Traversable LT?	N/A	N/A	Flare Traversable RT?	N/A
N/A	Landing Length (in)	N/A	N/A	DWS Provided?	N/A
N/A	Landing Width (in)	N/A	N/A	DWS Contrast?	N/A
N/A	Landing Slope (%)	N/A	N/A	DWS Length (in)	N/A
N/A	Landing X Slope (%)	N/A	N/A	DWS Full Width?	N/A
N/A	Landing Curb? (Y/N)	N/A	N/A	DWS Offset (in)	N/A
N/A	Shared Landing?	N/A			
N/A	Gutter Ponding?	N/A	N/A	Gutter Slope (%)	N/A
N/A	Gutter Lip Ht (in)	N/A	N/A	Gutter X Slope (%)	N/A
N/A	Painted X Walk1?	No	N/A	Painted X Walk2?	No
	X Walk 1 Direction	To SW		X Walk 2 Direction	To SE
N/A	X Walk 1 Width (in)	N/A	N/A	X Walk 2 Width (in)	N/A
	X Walk 1 Slope (%)	7.8		X Walk 2 Slope (%)	1.3
	X Walk 1 X Slope (%)	0.5		X Walk 2 X Slope (%)	9.4

N/A	Ramp inside XWalk1?	N/A	N/A	Ramp inside XWalk2?	N/A
	Road Slope (%)	5.7	N/A	Clear Space?	N/A
	Road X Slope (%)	4.2	N/A	Clear Space to XWalk (in)	N/A
N/A	Any Obstructions?	N/A	N/A	Storm Grate/Utility Hazard?	N/A
	Obstruction Type			Storm Grate/Utility Type	
		N/A			N/A
		Yes		Surface Condition? (G/P)	Good

**Remove & Replace Curb Ramp With Two New Directional Ramps or Equivalent.**

**R304.5.3**
