Access Compliance Report

Public Rights-of-Way

(Curb Ramps)

Intersection ID: 16080	Main Street: BUENA_VISTA_AV	Cross Street: LANIER_AV	Location: E
ADA ID: 65EBC6958DA6	Ramp Type: Directional1	Initial Pass/Fail: Fail	Overall Compliance: No
			Severity Score: 33.75

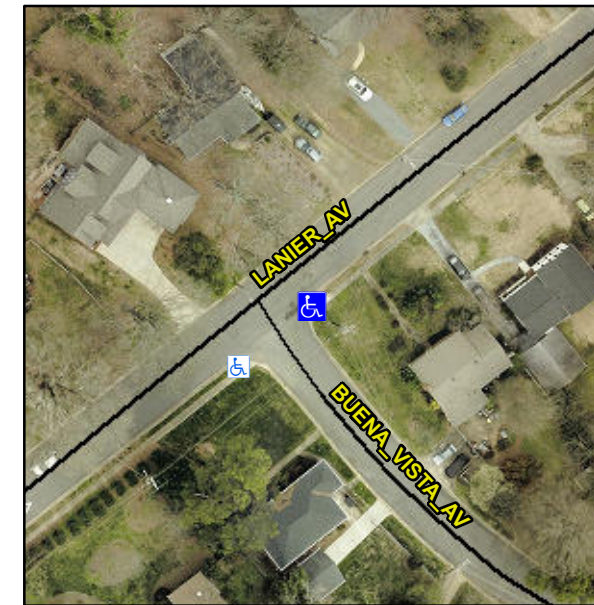
Compliance	Description	Data	Compliance	Description	Data
N/A	Ramp Length (in)	59.0	N/A	Grade Break?	N/A
No	Ramp Width (in)	41.0	N/A	Grade Break Slope (%)	0.0
Yes	Ramp Slope (%)	5.3	N/A	Grade Break XSlope (%)	0.0
No	Ramp XSlope (%)	7.6			
N/A	Flare Type LT	N/A	N/A	Flare Type RT	N/A
N/A	Flare Slope LT (%)	N/A	N/A	Flare Slope RT (%)	0.0
N/A	Flare Traversable LT?	N/A	N/A	Flare Traversable RT?	N/A
N/A	Landing Length (in)	0.0	N/A	DWS Provided?	N/A
N/A	Landing Width (in)	0.0	N/A	DWS Contrast?	N/A
N/A	Landing Slope (%)	0.0	N/A	DWS Length (in)	N/A
N/A	Landing X Slope (%)	0.0	N/A	DWS Full Width?	N/A
N/A	Landing Curb? (Y/N)	N/A	N/A	DWS Offset LT (in)	N/A
N/A	Shared Landing?	N/A	N/A	DWS Offset RT (in)	N/A
N/A	Gutter Ponding?	0.0	N/A	Gutter Slope (%)	N/A
N/A	Gutter Lip Ht (in)	0.0	N/A	Gutter X Slope (%)	N/A
N/A	Painted X Walk1?	No		Road Slope (%)	9.9
	X Walk 1 Direction	To SW		Road X Slope (%)	7.1
	X Walk 1 Width (in)	N/A		Clear Space?	N/A

X Walk 1 Slope (%)	9.9	N/A	Clear Space to XWalk (in)	N/A
	X Walk 1 X Slope (%)	7.1	N/A	Storm Grate/Utility Hazard?	N/A
N/A	Ramp inside XWalk1?	N/A		Storm Grate/Utility Type	
N/A	Any Obstructions?	N/A			
	Obstruction Type		Yes	Surface Condition? (G/P)	Good
			N/A	Curb Slope (%)	15.6

Possible Solutions:

Remove & Replace Entire Ramp.

R304.5.1, R304.5.3
