Access Compliance Report

Public Rights-of-Way

(Curb Ramps)

Intersection ID: 27431	Main Street: BALLANTYNE COMMONS PY	Cross Street: RUSHMORE DR	Location:	SW
ADA ID: 65EFFA0D627A	Ramp Type: Perpendicular	Initial Pass/Fail: Fail	Overall Compliance: No	Severity Score: 10
Codes/Mitigation Info/Possible Solution		Field Measurements/Component Compliance

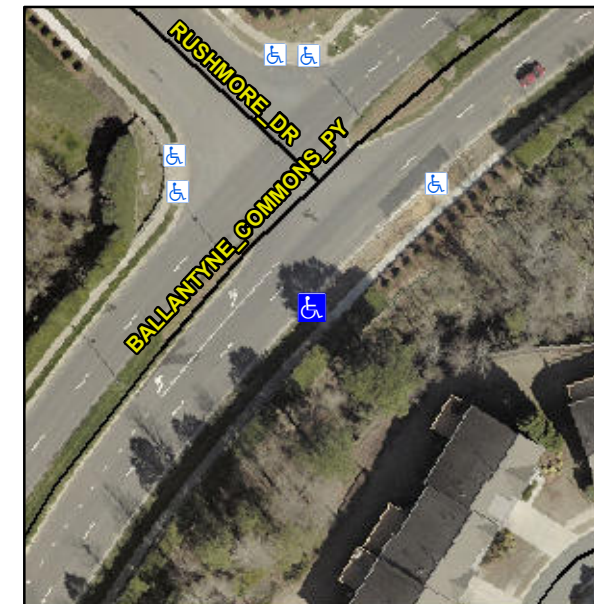
Not Found, R304.5.1, R304.5.3

Compliance	Description	Data	Compliance	Description	Data
N/A	Ramp Length (in)	119.0	Yes	Ramp Slope (%)	5.4
No	Ramp Width (in)	47.0	No	Ramp XSlope (%)	3.8
N/A	Flare Type LT	N/A	N/A	Flare Type RT	N/A
N/A	Flare Slope LT (%)	N/A	N/A	Flare Slope RT (%)	N/A
N/A	Flare Traversable LT?	N/A	N/A	Flare Traversable RT?	N/A
N/A	Landing Length (in)	N/A	N/A	DWS Provided?	N/A
N/A	Landing Width (in)	N/A	N/A	DWS Contrast?	N/A
N/A	Landing Slope (%)	N/A	N/A	DWS Length (in)	N/A
N/A	Landing X Slope (%)	N/A	N/A	DWS Full Width?	N/A
N/A	Landing Curb? (Y/N)	N/A	N/A	DWS Offset (in)	N/A
N/A	Shared Landing?	N/A			
N/A	Gutter Ponding?	N/A	N/A	Gutter Slope (%)	N/A
N/A	Gutter Lip Ht (in)	N/A	N/A	Gutter X Slope (%)	N/A
N/A	Painted X Walk1?	No	N/A	Painted X Walk2?	N/A
	X Walk 1 Direction	To NW		X Walk 2 Direction	N/A
N/A	X Walk 1 Width (in)	N/A	N/A	X Walk 2 Width (in)	N/A
	X Walk 1 Slope (%)	3.5		X Walk 2 Slope (%)	N/A
	X Walk 1 X Slope (%)	0.9		X Walk 2 X Slope (%)	N/A

N/A	Ramp inside XWalk1?	N/A	N/A	Ramp inside XWalk2?	N/A
	Road Slope (%)	N/A	N/A	Clear Space?	N/A
	Road X Slope (%)	N/A	N/A	Clear Space to XWalk (in)	N/A
N/A	Any Obstructions?	N/A	N/A	Storm Grate/Utility Hazard?	N/A
	Obstruction Type			Storm Grate/Utility Type	
		N/A			N/A
			Yes	Surface Condition? (G/P)	Good

Possible Solutions:

Remove & Replace Entire Ramp.
