# Access Compliance Report

## Public Rights-of-Way (Curb Ramps)

Intersection ID: 18089	Main Street: HARRIS_RD	Cross Street: SHARON_RD	Location: E
ADA ID: 65F0072B3B81	Ramp Type: Perpendicular Diagonal	Initial Pass/Fail: Fail	Overall Compliance: No
		Severity Score: 42.5

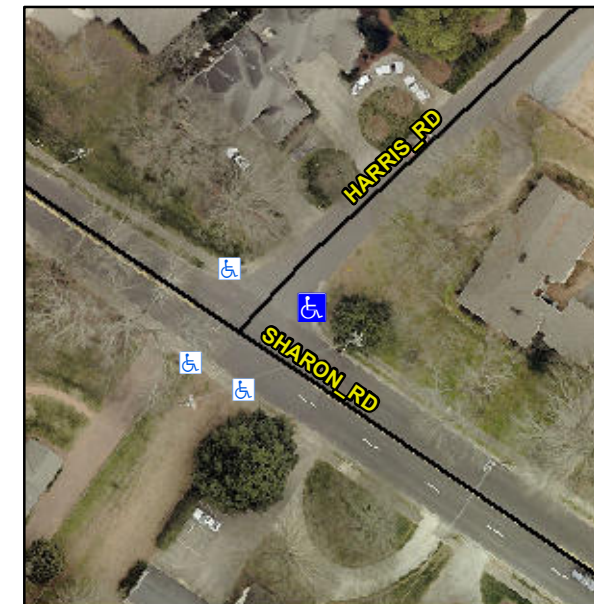
**Not Found, R304.5.1, R304.2.2, R304.5.3**

Compliance	Description	Data	Compliance	Description	Data
N/A	Ramp Length (in)	68.5	No	Ramp Slope (%)	10.2
No	Ramp Width (in)	32.0	No	Ramp XSlope (%)	5.3
N/A	Flare Type LT	N/A	N/A	Flare Type RT	N/A
N/A	Flare Slope LT (%)	N/A	N/A	Flare Slope RT (%)	N/A
N/A	Flare Traversable LT?	N/A	N/A	Flare Traversable RT?	N/A
N/A	Landing Length (in)	N/A	N/A	DWS Provided?	N/A
N/A	Landing Width (in)	N/A	N/A	DWS Contrast?	N/A
N/A	Landing Slope (%)	N/A	N/A	DWS Length (in)	N/A
N/A	Landing X Slope (%)	N/A	N/A	DWS Full Width?	N/A
N/A	Landing Curb? (Y/N)	N/A	N/A	DWS Offset (in)	N/A
N/A	Shared Landing?	N/A			
N/A	Gutter Ponding?	N/A	N/A	Gutter Slope (%)	N/A
N/A	Gutter Lip Ht (in)	N/A	N/A	Gutter X Slope (%)	N/A
N/A	Painted X Walk1?	No	N/A	Painted X Walk2?	No
	X Walk 1 Direction	To NW		X Walk 2 Direction	To SW
N/A	X Walk 1 Width (in)	N/A	N/A	X Walk 2 Width (in)	N/A
	X Walk 1 Slope (%)	5.9		X Walk 2 Slope (%)	3.5
	X Walk 1 X Slope (%)	1.9		X Walk 2 X Slope (%)	3.2

N/A	Ramp inside XWalk1?	N/A	N/A	Ramp inside XWalk2?	N/A
	Road Slope (%)	3.2	N/A	Clear Space?	N/A
	Road X Slope (%)	4.2	N/A	Clear Space to XWalk (in)	N/A
N/A	Any Obstructions?	N/A	N/A	Storm Grate/Utility Hazard?	N/A
	Obstruction Type			Storm Grate/Utility Type	
		N/A			N/A
			Yes	Surface Condition? (G/P)	Good

**Remove & Replace Curb Ramp With Two New Directional Ramps or Equivalent.**
