# Access Compliance Report

## Public Rights-of-Way (Curb Ramps)

Intersection ID: 53894	Main Street: INVERNESS_BAY_RD	Cross Street: PERTH_MOOR_RD	Location: SE
ADA ID: 65F5566183D7	Ramp Type: Perpendicular	Initial Pass/Fail: Fail	Overall Compliance: No
			Severity Score: 21.25

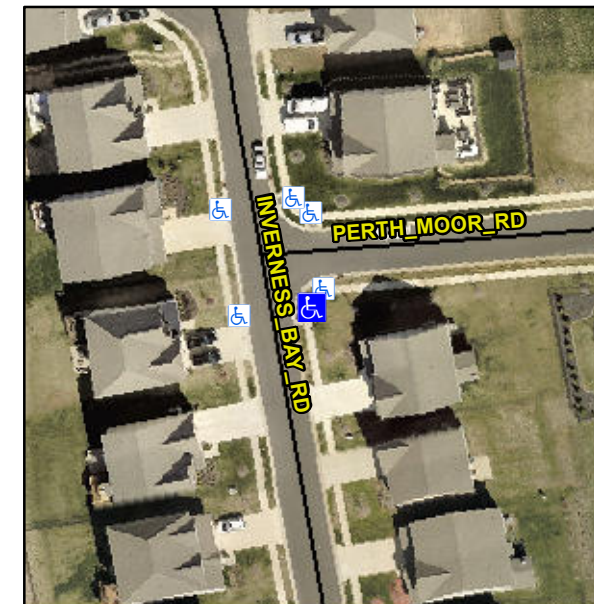
**Not Found, R304.5.1, R304.2.2**

Compliance	Description	Data	Compliance	Description	Data
N/A	Ramp Length (in)	45.0	No	Ramp Slope (%)	8.5
No	Ramp Width (in)	47.5	Yes	Ramp XSlope (%)	0.4
N/A	Flare Type LT	N/A	N/A	Flare Type RT	N/A
N/A	Flare Slope LT (%)	N/A	N/A	Flare Slope RT (%)	N/A
N/A	Flare Traversable LT?	N/A	N/A	Flare Traversable RT?	N/A
N/A	Landing Length (in)	N/A	N/A	DWS Provided?	N/A
N/A	Landing Width (in)	N/A	N/A	DWS Contrast?	N/A
N/A	Landing Slope (%)	N/A	N/A	DWS Length (in)	N/A
N/A	Landing X Slope (%)	N/A	N/A	DWS Full Width?	N/A
N/A	Landing Curb? (Y/N)	N/A	N/A	DWS Offset (in)	N/A
N/A	Shared Landing?	N/A			
N/A	Gutter Ponding?	N/A	N/A	Gutter Slope (%)	N/A
N/A	Gutter Lip Ht (in)	1.5	N/A	Gutter X Slope (%)	N/A
N/A	Painted X Walk1?	No	N/A	Painted X Walk2?	N/A
	X Walk 1 Direction	To W		X Walk 2 Direction	N/A
N/A	X Walk 1 Width (in)	N/A	N/A	X Walk 2 Width (in)	N/A
	X Walk 1 Slope (%)	3.1		X Walk 2 Slope (%)	N/A
	X Walk 1 X Slope (%)	0.2		X Walk 2 X Slope (%)	N/A

N/A	Ramp inside XWalk1?	N/A	N/A	Ramp inside XWalk2?	N/A
	Road Slope (%)	N/A	N/A	Clear Space?	N/A
	Road X Slope (%)	N/A	N/A	Clear Space to XWalk (in)	N/A
N/A	Any Obstructions?	N/A	N/A	Storm Grate/Utility Hazard?	N/A
	Obstruction Type			Storm Grate/Utility Type	
		N/A			N/A
			Yes	Surface Condition? (G/P)	Good

Possible Solutions:

**Remove & Replace Entire Ramp.**
