# Access Compliance Report

## Public Rights-of-Way

### (Curb Ramps)

Intersection ID: 12792	Main Street: E_HILL_ST	Cross Street: S_TRYON_ST	Location: E
ADA ID: 65F6B9DBF603	Ramp Type: Perpendicular	Initial Pass/Fail: Fail	Overall Compliance: No
Severity Score: 12.5			
Codes/Mitigation Info/Possible Solution		Field Measurements/Component Compliance

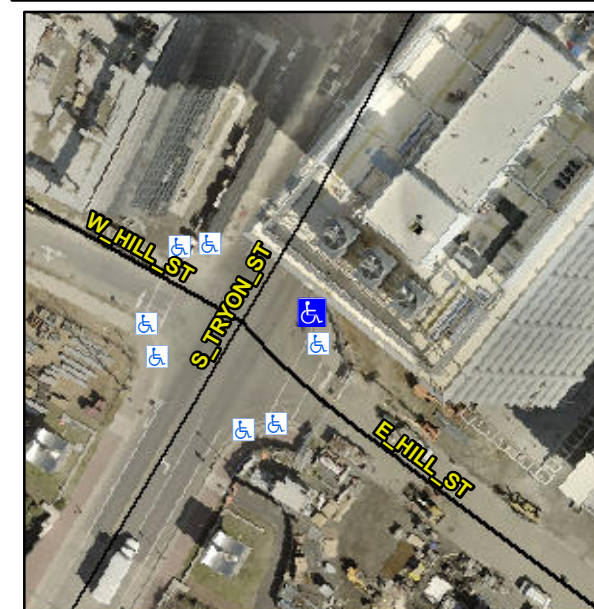
Compliance	Description	Data	Compliance	Description	Data
N/A	Ramp Length (in)	77.0	No	Ramp Slope (%)	9.3
Yes	Ramp Width (in)	48.0	Yes	Ramp XSlope (%)	1.4
N/A	Flare Type LT	N/A	N/A	Flare Type RT	N/A
N/A	Flare Slope LT (%)	N/A	N/A	Flare Slope RT (%)	N/A
N/A	Flare Traversable LT?	N/A	N/A	Flare Traversable RT?	N/A
N/A	Landing Length (in)	N/A	N/A	DWS Provided?	N/A
N/A	Landing Width (in)	N/A	N/A	DWS Contrast?	N/A
N/A	Landing Slope (%)	N/A	N/A	DWS Length (in)	N/A
N/A	Landing X Slope (%)	N/A	N/A	DWS Full Width?	N/A
N/A	Landing Curb? (Y/N)	N/A	N/A	DWS Offset (in)	N/A
N/A	Shared Landing?	N/A			
N/A	Gutter Ponding?	N/A	N/A	Gutter Slope (%)	N/A
N/A	Gutter Lip Ht (in)	N/A	N/A	Gutter X Slope (%)	N/A
N/A	Painted X Walk1?	No	N/A	Painted X Walk2?	N/A
	X Walk 1 Direction	To NW		X Walk 2 Direction	N/A
N/A	X Walk 1 Width (in)	N/A	N/A	X Walk 2 Width (in)	N/A
	X Walk 1 Slope (%)	3.2		X Walk 2 Slope (%)	N/A
	X Walk 1 X Slope (%)	1.2		X Walk 2 X Slope (%)	N/A

N/A	Ramp inside XWalk1?	N/A	N/A	Ramp inside XWalk2?	N/A
	Road Slope (%)	N/A	N/A	Clear Space?	N/A
	Road X Slope (%)	N/A	N/A	Clear Space to XWalk (in)	N/A
N/A	Any Obstructions?	N/A	N/A	Storm Grate/Utility Hazard?	N/A
	Obstruction Type			Storm Grate/Utility Type	
		N/A			N/A
			Yes	Surface Condition? (G/P)	Good

Possible Solutions:

**Remove & Replace Entire Ramp.**

**Not Found, R304.2.2**
