Access Compliance Report

Public Rights-of-Way

(Curb Ramps)

Intersection ID: 10025796	Main Street: EDGEHILL_RD_NORTH	Cross Street: N/A	Location: SE
ADA ID: 65F849D751FD	Ramp Type: PerpDiag	Initial Pass/Fail: Fail	Overall Compliance: No
Severity Score: 17.5			
Codes/Mitigation Info/Possible Solution		Field Measurements/Component Compliance

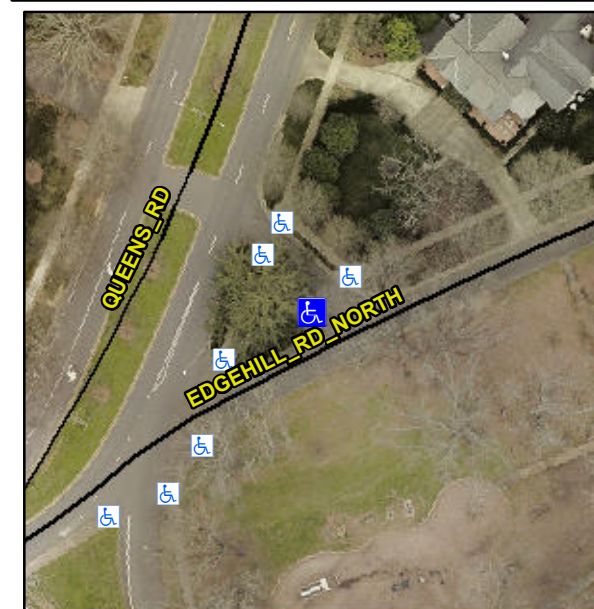
Compliance	Description	Data	Compliance	Description	Data
N/A	Ramp Length (in)	79.0	Yes	Ramp Slope (%)	6.7
No	Ramp Width (in)	35.0	Yes	Ramp XSlope (%)	2.0
N/A	Flare Type LT	N/A	N/A	Flare Type RT	N/A
N/A	Flare Slope LT (%)	N/A	N/A	Flare Slope RT (%)	N/A
N/A	Flare Traversable LT?	N/A	N/A	Flare Traversable RT?	N/A
N/A	Landing Length (in)	N/A	N/A	DWS Provided?	N/A
N/A	Landing Width (in)	N/A	N/A	DWS Contrast?	N/A
N/A	Landing Slope (%)	N/A	N/A	DWS Length (in)	N/A
N/A	Landing X Slope (%)	N/A	N/A	DWS Full Width?	N/A
N/A	Landing Curb? (Y/N)	N/A	N/A	DWS Offset (in)	N/A
N/A	Shared Landing?	N/A			
N/A	Gutter Ponding?	N/A	N/A	Gutter Slope (%)	N/A
N/A	Gutter Lip Ht (in)	N/A	N/A	Gutter X Slope (%)	N/A
N/A	Painted X Walk1?	No	N/A	Painted X Walk2?	No
	X Walk 1 Direction	To NE		X Walk 2 Direction	To SE
N/A	X Walk 1 Width (in)	N/A	N/A	X Walk 2 Width (in)	N/A
	X Walk 1 Slope (%)	3.9		X Walk 2 Slope (%)	5.9
	X Walk 1 X Slope (%)	6.4		X Walk 2 X Slope (%)	1.8

N/A	Ramp inside XWalk1?	N/A	N/A	Ramp inside XWalk2?	N/A
	Road Slope (%)	5.8	N/A	Clear Space?	N/A
	Road X Slope (%)	7.2	N/A	Clear Space to XWalk (in)	N/A
N/A	Any Obstructions?	N/A	N/A	Storm Grate/Utility Hazard?	N/A
	Obstruction Type			Storm Grate/Utility Type	
		N/A			N/A
			Yes	Surface Condition? (G/P)	Good

Possible Solutions:

Remove & Replace Curb Ramp With Two New Directional Ramps or Equivalent.

R304.5.1
