# Access Compliance Report

## Public Rights-of-Way

### (Curb Ramps)

Intersection ID: 31202	Main Street: OAKTON_HUNT_DR	Cross Street: WRAYHILL_DR	Location: S
ADA ID: 6600C579B33C	Ramp Type: Perpendicular Diagonal	Initial Pass/Fail: Fail	Overall Compliance: No
		Severity Score: 10

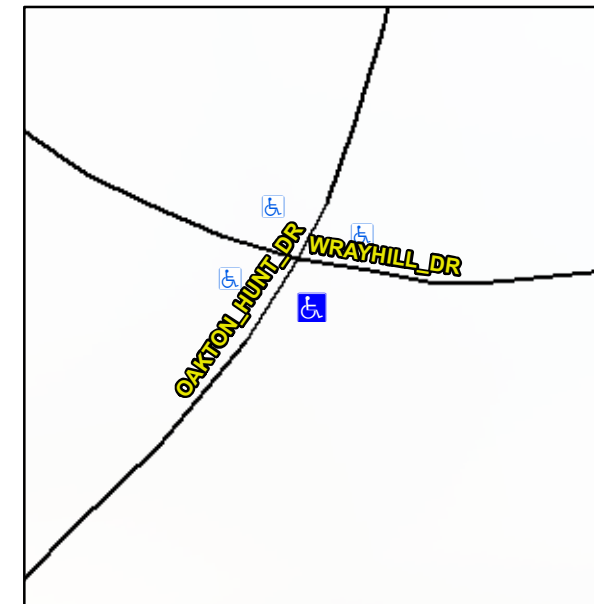
**Not Found, R304.5.1, R304.5.3**

Compliance	Description	Data	Compliance	Description	Data
N/A	Ramp Length (in)	48.0	Yes	Ramp Slope (%)	5.2
No	Ramp Width (in)	41.0	No	Ramp XSlope (%)	4.9
N/A	Flare Type LT	N/A	N/A	Flare Type RT	N/A
N/A	Flare Slope LT (%)	N/A	N/A	Flare Slope RT (%)	N/A
N/A	Flare Traversable LT?	N/A	N/A	Flare Traversable RT?	N/A
N/A	Landing Length (in)	N/A	N/A	DWS Provided?	N/A
N/A	Landing Width (in)	N/A	N/A	DWS Contrast?	N/A
N/A	Landing Slope (%)	N/A	N/A	DWS Length (in)	N/A
N/A	Landing X Slope (%)	N/A	N/A	DWS Full Width?	N/A
N/A	Landing Curb? (Y/N)	N/A	N/A	DWS Offset (in)	N/A
N/A	Shared Landing?	N/A			
N/A	Gutter Ponding?	N/A	N/A	Gutter Slope (%)	N/A
N/A	Gutter Lip Ht (in)	N/A	N/A	Gutter X Slope (%)	N/A
N/A	Painted X Walk1?	No	N/A	Painted X Walk2?	No
	X Walk 1 Direction	To NE		X Walk 2 Direction	To NW
N/A	X Walk 1 Width (in)	N/A	N/A	X Walk 2 Width (in)	N/A
	X Walk 1 Slope (%)	6.0		X Walk 2 Slope (%)	5.6
	X Walk 1 X Slope (%)	4.2		X Walk 2 X Slope (%)	3.7

N/A	Ramp inside XWalk1?	N/A	N/A	Ramp inside XWalk2?	N/A
	Road Slope (%)	5.3	N/A	Clear Space?	N/A
	Road X Slope (%)	4.5	N/A	Clear Space to XWalk (in)	N/A
N/A	Any Obstructions?	N/A	N/A	Storm Grate/Utility Hazard?	N/A
	Obstruction Type			Storm Grate/Utility Type	
		N/A			N/A
			Yes	Surface Condition? (G/P)	Good

**Remove & Replace Curb Ramp With Two New Directional Ramps or Equivalent.**
