Access Compliance Report

Public Rights-of-Way

(Curb Ramps)

Intersection ID: 14530	Main Street: E_5TH_ST	Cross Street: N_LAUREL_AV	Location: S
ADA ID: 6603C6D8DE88	Ramp Type: Perp	Initial Pass/Fail: Fail	Overall Compliance: No
		Severity Score: 12.5

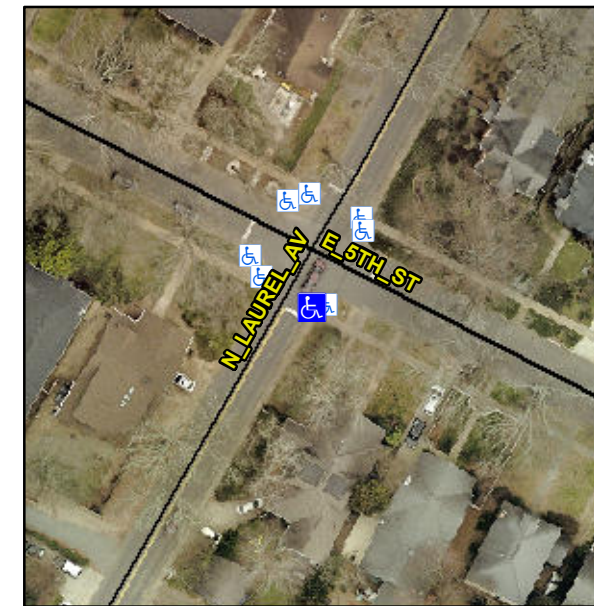
Not Found, R304.2.2

Compliance	Description	Data	Compliance	Description	Data
N/A	Ramp Length (in)	50.0	No	Ramp Slope (%)	8.6
Yes	Ramp Width (in)	48.0	Yes	Ramp XSlope (%)	1.0
N/A	Flare Type LT	N/A	N/A	Flare Type RT	N/A
N/A	Flare Slope LT (%)	N/A	N/A	Flare Slope RT (%)	N/A
N/A	Flare Traversable LT?	N/A	N/A	Flare Traversable RT?	N/A
N/A	Landing Length (in)	N/A	N/A	DWS Provided?	N/A
N/A	Landing Width (in)	N/A	N/A	DWS Contrast?	N/A
N/A	Landing Slope (%)	N/A	N/A	DWS Length (in)	N/A
N/A	Landing X Slope (%)	N/A	N/A	DWS Full Width?	N/A
N/A	Landing Curb? (Y/N)	N/A	N/A	DWS Offset (in)	N/A
N/A	Shared Landing?	N/A			
N/A	Gutter Ponding?	N/A	N/A	Gutter Slope (%)	N/A
N/A	Gutter Lip Ht (in)	N/A	N/A	Gutter X Slope (%)	N/A
N/A	Painted X Walk1?	No	N/A	Painted X Walk2?	N/A
	X Walk 1 Direction	To NW		X Walk 2 Direction	N/A
N/A	X Walk 1 Width (in)	N/A	N/A	X Walk 2 Width (in)	N/A
	X Walk 1 Slope (%)	2.4		X Walk 2 Slope (%)	N/A
	X Walk 1 X Slope (%)	3.5		X Walk 2 X Slope (%)	N/A

Remove & Replace Entire Ramp.
