# Access Compliance Report

## Public Rights-of-Way

### (Curb Ramps)

Intersection ID: 53747	Main Street: BELVEDERE CASTLE DR	Cross Street: CANTERBURY CASTLE DR	Location: NW
ADA ID: 661BD64D9FB2	Ramp Type: Perp	Initial Pass/Fail: Fail	Overall Compliance: No
Codes/Mitigation Info/Possible Solution		Field Measurements/Component Compliance	
Severity Score: 8.75

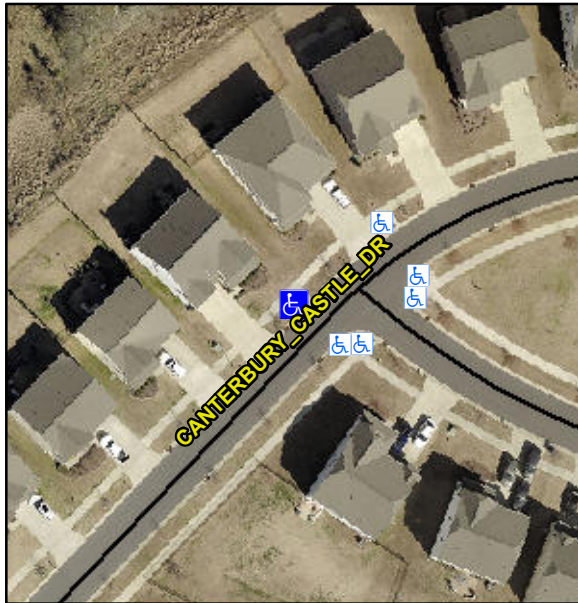
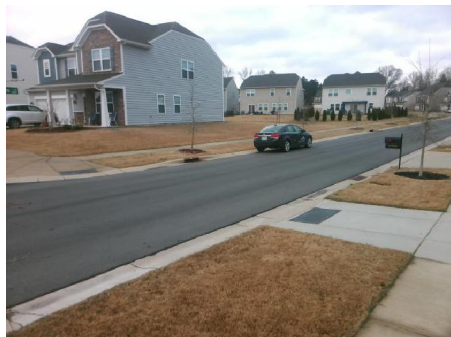
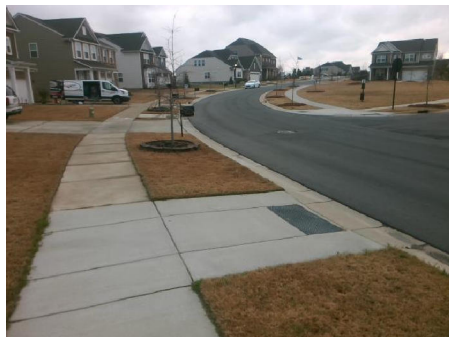
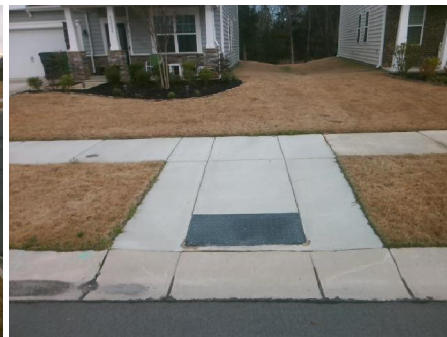
Compliance	Description	Data	Compliance	Description	Data
N/A	Ramp Length (in)	94.0	Yes	Ramp Slope (%)	6.5
No	Ramp Width (in)	46.5	Yes	Ramp XSlope (%)	1.3
N/A	Flare Type LT	N/A	N/A	Flare Type RT	N/A
N/A	Flare Slope LT (%)	N/A	N/A	Flare Slope RT (%)	N/A
N/A	Flare Traversable LT?	N/A	N/A	Flare Traversable RT?	N/A
N/A	Landing Length (in)	N/A	N/A	DWS Provided?	N/A
N/A	Landing Width (in)	N/A	N/A	DWS Contrast?	N/A
N/A	Landing Slope (%)	N/A	N/A	DWS Length (in)	N/A
N/A	Landing X Slope (%)	N/A	N/A	DWS Full Width?	N/A
N/A	Landing Curb? (Y/N)	N/A	N/A	DWS Offset (in)	N/A
N/A	Shared Landing?	N/A			
N/A	Gutter Ponding?	N/A	N/A	Gutter Slope (%)	N/A
N/A	Gutter Lip Ht (in)	N/A	N/A	Gutter X Slope (%)	N/A
N/A	Painted X Walk1?	No	N/A	Painted X Walk2?	N/A
	X Walk 1 Direction	To SE		X Walk 2 Direction	N/A
N/A	X Walk 1 Width (in)	N/A	N/A	X Walk 2 Width (in)	N/A
	X Walk 1 Slope (%)	3.4		X Walk 2 Slope (%)	N/A
	X Walk 1 X Slope (%)	0.9		X Walk 2 X Slope (%)	N/A

N/A	Ramp inside XWalk1?	N/A	N/A	Ramp inside XWalk2?	N/A
	Road Slope (%)	N/A	N/A	Clear Space?	N/A
	Road X Slope (%)	N/A	N/A	Clear Space to XWalk (in)	N/A
N/A	Any Obstructions?	N/A	N/A	Storm Grate/Utility Hazard?	N/A
	Obstruction Type			Storm Grate/Utility Type	
		N/A			N/A
			Yes	Surface Condition? (G/P)	Good

**Remove & Replace Entire Ramp.**

**R304.5.1**
