Access Compliance Report

Public Rights-of-Way

(Curb Ramps)

| Intersection ID: 16329 | Main Street: DAWNWOOD_DR | Cross Street: HELMDALE_AV | Location: SE |

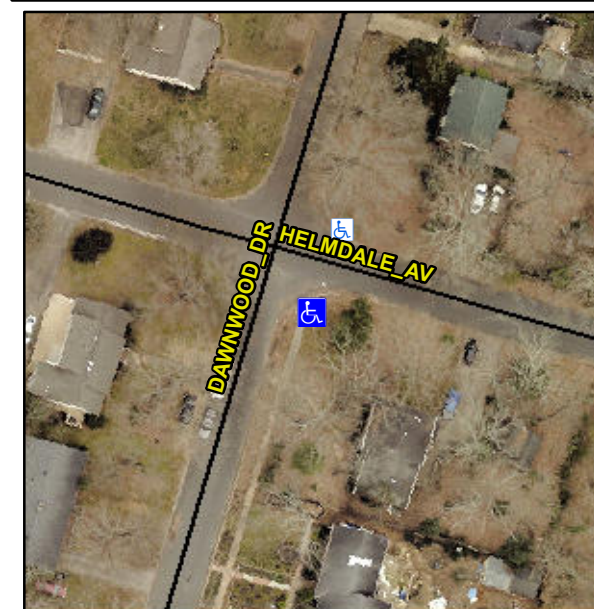
| ADA ID: 663AC639C0C6 | Ramp Type: PerpDiag | Initial Pass/Fail: Fail | Overall Compliance: No |
| Severity Score: 12.5 | | | |

Not Found, R304.2.2

| Compliance | Description | Data | Compliance | Description | Data |
|---|---|---|---|---|---|
| N/A | Ramp Length (in) | 66.0 | No | Ramp Slope (%) | 9.7 |

Remove & Replace Curb Ramp With Two New Directional Ramps or Equivalent.
