# Access Compliance Report

## Public Rights-of-Way

### (Curb Ramps)

Intersection ID: 9658	Main Street: VANDERBILT_RD	Cross Street: WOODWARD_AV	Location: NW
ADA ID: 663B862EC420	Ramp Type: Para	Initial Pass/Fail: Fail	Overall Compliance: No
Codes/Mitigation Info/Possible Solution		Field Measurements/Component Compliance	
Severity Score: 37.5

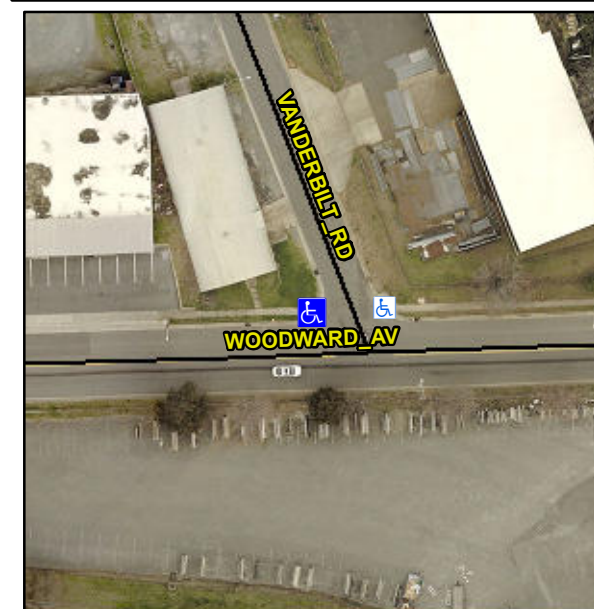
**CURB GAP 1.0, LT RP < 5%**

**R304.5.3, R304.3.2**

Compliance	Description	Data	Compliance	Description	Data
N/A	Ramp Length LT (in)	10.0	N/A	Ramp Length RT (in)	44.0
Yes	Ramp Width LT (in)	81.0	Yes	Ramp Width RT (in)	70.5
Yes	Ramp Slope LT (%)	2.1	No	Ramp Slope RT (%)	13.4
No	Ramp XSlope LT (%)	5.1	Yes	Ramp XSlope RT (%)	0.7
N/A	Landing Length (in)	N/A	N/A	DWS Provided?	N/A
N/A	Landing Width (in)	N/A	N/A	DWS Contrast?	N/A
N/A	Landing Slope (%)	N/A	N/A	DWS Length (in)	N/A
N/A	Landing X Slope (%)	N/A	N/A	DWS Full Width?	N/A
N/A	Landing Curb? (Y/N)	N/A	N/A	DWS Offset (in)	N/A
N/A	Shared Landing?	N/A			
N/A	Gutter Ponding?	N/A	N/A	Gutter Slope (%)	N/A
N/A	Gutter Lip Ht (in)	N/A	N/A	Gutter X Slope (%)	N/A
N/A	Painted X Walk1?	No	N/A	Painted X Walk2?	N/A
	X Walk 1 Direction	To E		X Walk 2 Direction	N/A
N/A	X Walk 1 Width (in)	N/A	N/A	X Walk 2 Width (in)	N/A
	X Walk 1 Slope (%)	3.5		X Walk 2 Slope (%)	N/A
	X Walk 1 X Slope (%)	2.5		X Walk 2 X Slope (%)	N/A
N/A	Ramp inside XWalk1?	N/A	N/A	Ramp inside XWalk2?	N/A

Road Slope (%)	N/A	N/A	Clear Space?	N/A
	Road X Slope (%)	N/A	N/A	Clear Space to XWalk (in)	N/A
N/A	Any Obstructions?	N/A	N/A	Storm Grate/Utility Hazard?	N/A
	Obstruction Type			Storm Grate/Utility Type	
		N/A			N/A
			Yes	Surface Condition? (G/P)	Good
			N/A	Curb Slope (%)	18.2

**Remove & Replace Entire Ramp.**
