Access Compliance Report

Public Rights-of-Way

(Curb Ramps)

Intersection ID: 12165	Main Street: E_15TH_ST	Cross Street: HARRILL_ST	Location: E
ADA ID: 6642D5DC2C51	Ramp Type: PerpDiag	Initial Pass/Fail: Fail	Overall Compliance: No
		Severity Score: 8.75

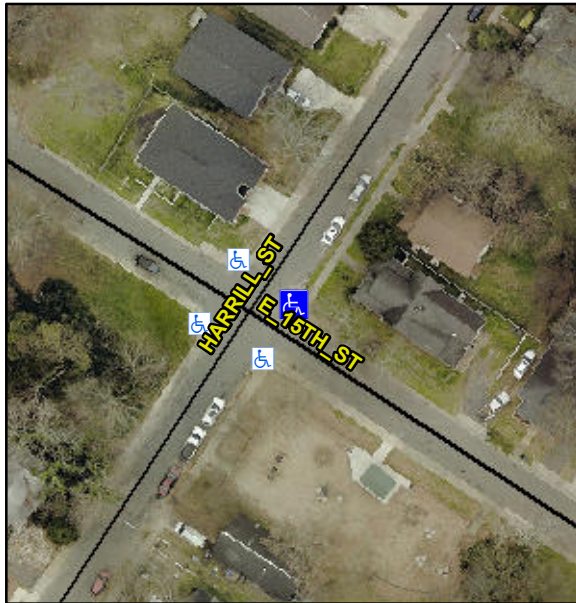
Not Found, R304.5.1

Compliance	Description	Data	Compliance	Description	Data
N/A	Ramp Length (in)	44.0	Yes	Ramp Slope (%)	6.2
No	Ramp Width (in)	46.0	Yes	Ramp XSlope (%)	1.8
N/A	Flare Type LT	N/A	N/A	Flare Type RT	N/A
N/A	Flare Slope LT (%)	N/A	N/A	Flare Slope RT (%)	N/A
N/A	Flare Traversable LT?	N/A	N/A	Flare Traversable RT?	N/A
N/A	Landing Length (in)	N/A	N/A	DWS Provided?	N/A
N/A	Landing Width (in)	N/A	N/A	DWS Contrast?	N/A
N/A	Landing Slope (%)	N/A	N/A	DWS Length (in)	N/A
N/A	Landing X Slope (%)	N/A	N/A	DWS Full Width?	N/A
N/A	Landing Curb? (Y/N)	N/A	N/A	DWS Offset (in)	N/A
N/A	Shared Landing?	N/A			
N/A	Gutter Ponding?	N/A	N/A	Gutter Slope (%)	N/A
N/A	Gutter Lip Ht (in)	0.5	N/A	Gutter X Slope (%)	N/A
N/A	Painted X Walk1?	No	N/A	Painted X Walk2?	No
	X Walk 1 Direction	To NW		X Walk 2 Direction	To SW
N/A	X Walk 1 Width (in)	N/A	N/A	X Walk 2 Width (in)	N/A
	X Walk 1 Slope (%)	1.0		X Walk 2 Slope (%)	2.3
	X Walk 1 X Slope (%)	1.0		X Walk 2 X Slope (%)	1.0

N/A	Ramp inside XWalk1?	N/A	N/A	Ramp inside XWalk2?	N/A
	Road Slope (%)	1.5	N/A	Clear Space?	N/A
	Road X Slope (%)	1.0	N/A	Clear Space to XWalk (in)	N/A
N/A	Any Obstructions?	N/A	N/A	Storm Grate/Utility Hazard?	N/A
	Obstruction Type			Storm Grate/Utility Type	
		N/A			N/A
			Yes	Surface Condition? (G/P)	Good

Remove & Replace Curb Ramp With Two New Directional Ramps or Equivalent.
