Intersection ID: 23356	Main Street: GRANITE_ST	Cross Street: WESTINGHOUSE_BV	Location:	NW
ADA ID: 664ADF8D2688	Ramp Type: PerpDiag	Initial Pass/Fail: Fail	Overall Compliance: No	Severity Score: 33.75

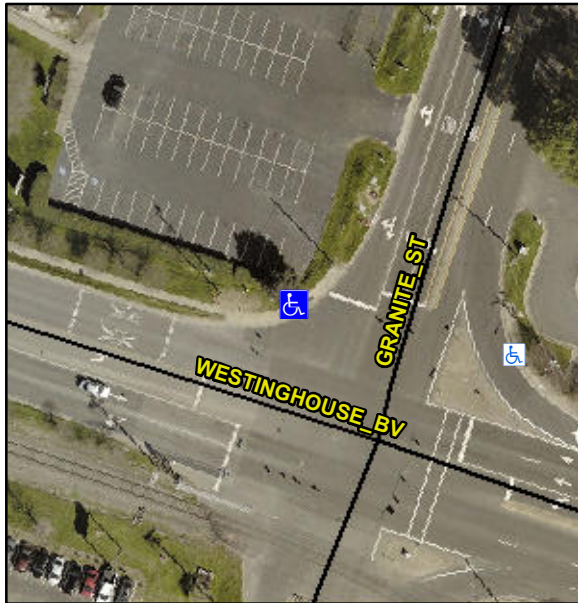
Not Found, R304.5.1, R304.2.2

Compliance	Description	Data	Compliance	Description	Data
N/A	Ramp Length (in)	60.0	No	Ramp Slope (%)	13.9
No	Ramp Width (in)	40.0	Yes	Ramp XSlope (%)	1.2
N/A	Flare Type LT	N/A	N/A	Flare Type RT	N/A
N/A	Flare Slope LT (%)	N/A	N/A	Flare Slope RT (%)	N/A
N/A	Flare Traversable LT?	N/A	N/A	Flare Traversable RT?	N/A
N/A	Landing Length (in)	N/A	N/A	DWS Provided?	N/A
N/A	Landing Width (in)	N/A	N/A	DWS Contrast?	N/A
N/A	Landing Slope (%)	N/A	N/A	DWS Length (in)	N/A
N/A	Landing X Slope (%)	N/A	N/A	DWS Full Width?	N/A
N/A	Landing Curb? (Y/N)	N/A	N/A	DWS Offset (in)	N/A
N/A	Shared Landing?	N/A			
N/A	Gutter Ponding?	N/A	N/A	Gutter Slope (%)	N/A
N/A	Gutter Lip Ht (in)	N/A	N/A	Gutter X Slope (%)	N/A
N/A	Painted X Walk1?	No	N/A	Painted X Walk2?	No
	X Walk 1 Direction	To S		X Walk 2 Direction	To E
N/A	X Walk 1 Width (in)	N/A	N/A	X Walk 2 Width (in)	N/A
	X Walk 1 Slope (%)	2.4		X Walk 2 Slope (%)	2.1
	X Walk 1 X Slope (%)	1.3		X Walk 2 X Slope (%)	2.7

N/A	Ramp inside XWalk1?	N/A	N/A	Ramp inside XWalk2?	N/A
	Road Slope (%)	1.5	N/A	Clear Space?	N/A
	Road X Slope (%)	3.2	N/A	Clear Space to XWalk (in)	N/A
N/A	Any Obstructions?	N/A	N/A	Storm Grate/Utility Hazard?	N/A
	Obstruction Type			Storm Grate/Utility Type	
		N/A			N/A
			Yes	Surface Condition? (G/P)	Good

Possible Solutions:

Remove & Replace Curb Ramp With Two New Directional Ramps or Equivalent.
