# Access Compliance Report

## Public Rights-of-Way

### (Curb Ramps)

Intersection ID: 10759	Main Street: SPRATT_ST	Cross Street: OLIVER_ST	Location: SE
ADA ID: 664B7AE5CFEA	Ramp Type: Combination2	Initial Pass/Fail: Fail	Overall Compliance: No
			Severity Score: 48.75

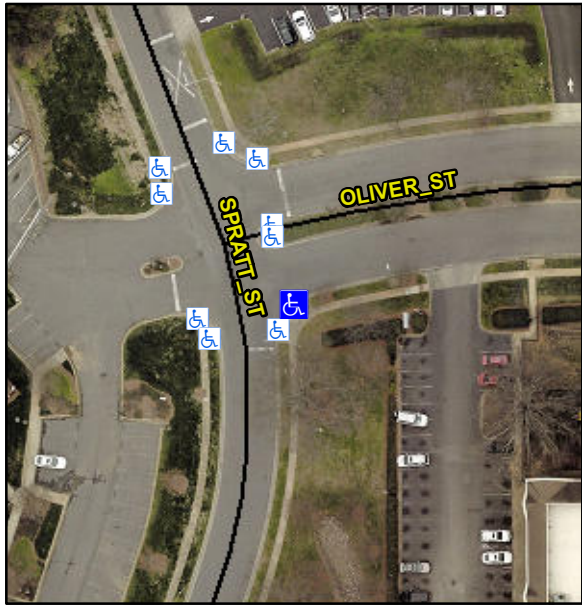
Possible Solutions:		Compliance	Description	Data	Compliance	Description	Data
	Remove & Replace Entire Ramp.		N/A	Ramp Length LT (in)	30.0	N/A	Ramp Length RT (in)	45.0
			N/A	Ramp Width LT (in)	54.0	No	Ramp Width RT (in)	30.0
			N/A	Ramp Slope LT (%)	4.2	No	Ramp Slope RT (%)	10.0
			N/A	Ramp XSlope LT (%)	1.6	Yes	Ramp XSlope RT (%)	2.0
			N/A	Ramp Length (in)	103.5	Yes	Ramp Slope (%)	7.6
			Yes	Ramp Width (in)	50.5	Yes	Ramp XSlope (%)	2.4
	Surveyor Notes:		N/A	Flare Type LT	N/A	N/A	Flare Type RT	N/A
	LT RP < 5%		N/A	Flare Slope LT (%)	N/A	N/A	Flare Slope RT (%)	N/A
			N/A	Flare Traversable LT?	N/A	N/A	Flare Traversable RT?	N/A
			N/A	Landing Length (in)	N/A	N/A	DWS Provided?	N/A
			N/A	Landing Width (in)	N/A	N/A	DWS Contrast?	N/A
	PROW/ADA:		N/A	Landing Slope (%)	N/A	N/A	DWS Length (in)	N/A
	Not Found, R304.5.1, R304.3.2		N/A	Landing X Slope (%)	N/A	N/A	DWS Full Width?	N/A

N/A	Landing Curb? (Y/N)	N/A	N/A	DWS Offset (in)	N/A
			N/A	Shared Landing?	N/A			
			N/A	Gutter Ponding?	N/A	N/A	Gutter Slope (%)	N/A
			N/A	Gutter Lip Ht (in)	N/A	N/A	Gutter X Slope (%)	N/A
			N/A	Painted X Walk1?	No	N/A	Painted X Walk2?	N/A
Street 1 Name		None		X Walk 1 Direction	To N		X Walk 2 Direction	N/A
Stop Condition-Street 1		OLIVER ST		X Walk 1 Width (in)	N/A		X Walk 2 Width (in)	N/A
Street 2 Name		N/A		X Walk 1 Slope (%)	3.5		X Walk 2 Slope (%)	N/A
Stop Condition-Street 2		N/A		X Walk 1 X Slope (%)	3.1		X Walk 2 X Slope (%)	N/A
Total Cost:		\$ 1600.00	N/A	Ramp inside XWalk1?	N/A	N/A	Ramp inside XWalk2?	N/A
				Road Slope (%)	N/A		Clear Space?	N/A
				Road X Slope (%)	N/A	N/A	Clear Space to XWalk (in)	N/A
						N/A	Any Obstruction?	N/A
							Obstruction Type	N/A
						N/A	Storm Grate/Utility Hazard?	N/A
							Storm Grate/Utility Type	N/A
						Yes	Surface Condition? (G/P)	Good
							Curb Slope (%)	31.0
