## Access Compliance Report Public Rights-of-Way (Curb Ramps)

Intersection ID: 6228 Main Street: E.W.T. HAPPIS DA				Cross Street, UNIVERSITY CITY BV				Location:	SE
	Main Street: E_W_T_HARRIS_RA			Cross Street: UNIVERSITY_CITY_BV					
ADA ID: 6665C3D7042E	Ramp Type: Perp			Initial Pass/Fail: Fail Overall Compliance: I			nce: N	o Severity Score:	12.5
Codes/Mitigation Info/Possible Solution				Field Measurements/Component Compliance					
	1 1	Possible Solutions:		Compliance Description		Data Compliance Description		liance Description	Data
516 818 1	1/4	Remove & Replace Entire Ram	р.	N/A	Ramp Length (in)	58.0	Yes	Ramp Slope (%)	6.7
A A A		•	•	Yes	Ramp Width (in)	48.0	No	Ramp XSlope (%)	5.6
A RANK				N/A	Flare Type LT	N/A	N/A	Flare Type RT	N/A
A BU	44			N/A	Flare Slope LT (%)	N/A	N/A	Flare Slope RT (%)	N/A
A C ASIA	11.1			N/A	Flare Traversable LT?	N/A	N/A	Flare Traversable RT?	N/A
TITLE IN CASE	1 the			N/A	Landing Length (in)	N/A	N/A	DWS Provided?	N/A
	Se The	Surveyor Notes:		N/A	Landing Width (in)	N/A	N/A	DWS Contrast?	N/A

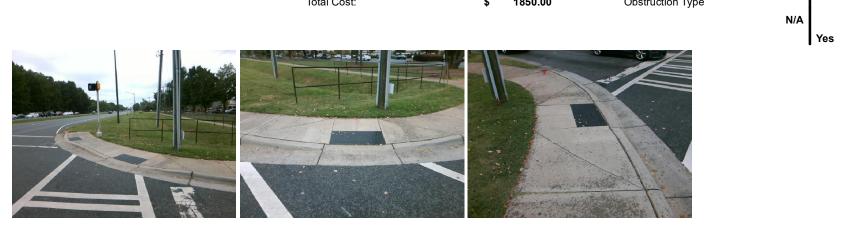
8/	N/A		N/A	Landing Slope (%)	N/A	N/A	DWS Length (in)	N/A
				N/A	Landing X Slope (%)	N/A	N/A	DWS Full Width?	N/A
	del-			N/A	Landing Curb? (Y/N)	N/A	N/A	DWS Offset (in)	N/A
1,/ A.	226			N/A	Shared Landing?	N/A			
1-	1/10	PROW/ADA:		N/A	Gutter Ponding?	N/A	N/A	Gutter Slope (%)	N/A
all the second	1	Not Found, R304.5.3		N/A	Gutter Lip Ht (in)	N/A	N/A	Gutter X Slope (%)	N/A
A LAND	4	,		N/A	Painted X Walk1?	Yes	N/A	Painted X Walk2?	N/A
	Sec.				X Walk 1 Direction	To W		X Walk 2 Direction	N/A
				N/A	X Walk 1 Width (in)	85.0	N/A	X Walk 2 Width (in)	N/A
Street 1 Name E W T HARI	RIS BV				X Walk 1 Slope (%)	0.8		X Walk 2 Slope (%)	N/A
Stop Condition-Street 2	Signal				X Walk 1 X Slope (%)	5.2		X Walk 2 X Slope (%)	N/A
Street 2 Name	N/A			N/A	Ramp inside XWalk1?	Yes	N/A	Ramp inside XWalk2?	N/A
Stop Condition-Street 1	N/A				Road Slope (%)	N/A	N/A	Clear Space?	N/A
					Road X Slope (%)	N/A	N/A	Clear Space to XWalk (in)	N/A

N/A	Any Obstructions?	N/A	N/A	Storm Grate/Utility Hazard?	N/A
		Total Cost: \$	1850.00		Obstruction Type			Storm Grate/Utility Type	
						N/A			N/A
