## Access Compliance Report Public Rights-of-Way (Curb Ramps)

Intersection ID: 7012	: 7012 Main Street: HUTCHISON-MCDONALD_RD					Cross Street: LYNCH_DR				S	
ADA ID: 666E013E05F4	Ramp Type: Perp			Initial	Initial Pass/Fail: Fail Overall Complian			nce: N	o Severity Score:	16.25	
Codes/Mitigation Info/Possible Solution					Field Measurements/Component Compliance						
		Possible Solutions:			Compliance Description			Data Compliance Description			
		Remove & Replace Entir	e Ran	ıp.	N/A	Ramp Length (in)	46.0	Yes	Ramp Slope (%)	6.3

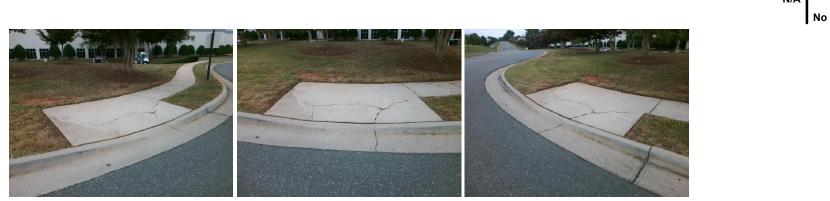
-			Yes	Ramp Width (in)	48.0	No	Ramp XSlope (%)	2.5	
ATURE +					N/A	Flare Type LT	N/A	N/A	Flare Type RT	N/A	
MUTCHISCONFILED					N/A	Flare Slope LT (%)	N/A	N/A	Flare Slope RT (%)	N/A

Surface Condition? (G/P)

Poor
