Access Compliance Report

Public Rights-of-Way

(Curb Ramps)

| Intersection ID: 10458 | Main Street: KESWICK_AV | Cross Street: GRIMES_ST | Location: NE |

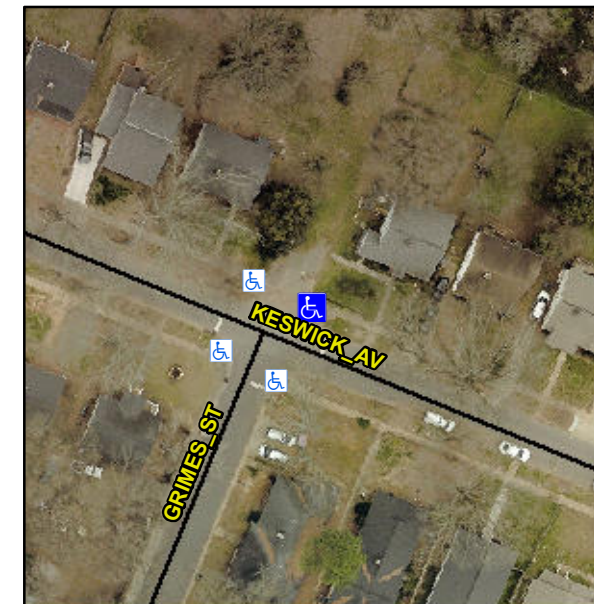
| Severity Score: 8.75 | | | |

Not Found, R304.5.1

| Compliance | Description | Data | Compliance | Description | Data |
|---|---|---|---|---|---|
| No | Ramp Width (in) | 42.0 | Yes | Ramp XSlope (%) | 1.1 |

Remove & Replace Entire Ramp.
