## Access Compliance Report Public Rights-of-Way (Curb Ramps)

Intersection ID: 7953Main Street:MARIETTA\_STCross Street:DAVID\_AVLocation:N/AADA ID: 668E448AD398Ramp Type:PerpInitial Pass/Fail:FailOverall Compliance:NoSeverity Score:33.75

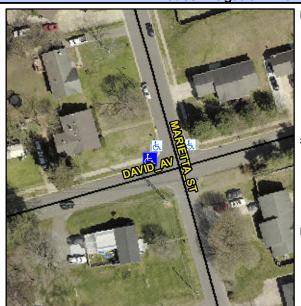
Field Measurements/Component Compliance						
Comp	Compliance Description Date		Comp	liance Description	Data	
N/A	Ramp Length (in)	48.0	Yes	Ramp Slope (%)	5.7	
No	Ramp Width (in)	46.5	No	Ramp XSlope (%)	8.4	
N/A	Flare Type LT	N/A	N/A	Flare Type RT	N/A	
N/A	Flare Slope LT (%)	N/A	N/A	Flare Slope RT (%)	N/A	
N/A	Flare Traversable LT?	N/A	N/A	Flare Traversable RT?	N/A	
N/A	Landing Length (in)	N/A	N/A	DWS Provided?	N/A	
N/A	Landing Width (in)	N/A	N/A	DWS Contrast?	N/A	
N/A	Landing Slope (%)	N/A	N/A	DWS Length (in)	N/A	
N/A	Landing X Slope (%)	N/A	N/A	DWS Full Width?	N/A	
N/A	Landing Curb? (Y/N)	N/A	N/A	DWS Offset (in)	N/A	
N/A	Shared Landing?	N/A				
N/A	Gutter Ponding?	N/A	N/A	Gutter Slope (%)	N/A	
N/A	Gutter Lip Ht (in)	2.0	N/A	Gutter X Slope (%)	N/A	
N/A	Painted X Walk1?	No	N/A	Painted X Walk2?	N/A	
	X Walk 1 Direction	To S		X Walk 2 Direction	N/A	
N/A	X Walk 1 Width (in)	N/A	N/A	X Walk 2 Width (in)	N/A	
	X Walk 1 Slope (%)	6.7		X Walk 2 Slope (%)	N/A

X Walk 1 X Slope (%)	5.8		X Walk 2 X Slope (%)	N/A	
N/A	Ramp inside XWalk1?	N/A	N/A	Ramp inside XWalk2?	N/A	
	Road Slope (%)	5.8	N/A	Clear Space?	N/A	
	Road X Slope (%)	6.7	N/A	Clear Space to XWalk (in)	N/A	
N/A	Any Obstructions?	N/A	N/A	Storm Grate/Utility Hazard?	N/A	
	Obstruction Type			Storm Grate/Utility Type		
		N/A			N/A	
			Yes	Surface Condition? (G/P)	Good

Possible Solutions:	<u> </u>	
Remove & Replace Entire Ramp.		
	N	
	N	
	N	
	N	
	N	
Surveyor Notes:	N	
N/A	N	
	N	
	N	
	N	
PROW/ADA:	N	
Not Found, R304.5.1, R304.5.3	N	
	N	
	N	
	N
