Access Compliance Report

Public Rights-of-Way

(Curb Ramps)

Intersection ID: 8931	Main Street: BANCROFT_ST	Cross Street: ENNIS_AV	Location: S
ADA ID: 66B62D5658D6	Ramp Type: BlendTrans1	Initial Pass/Fail: Fail	Overall Compliance: No
Severity Score: 12.5			
Codes/Mitigation Info/Possible Solution		Field Measurements/Component Compliance

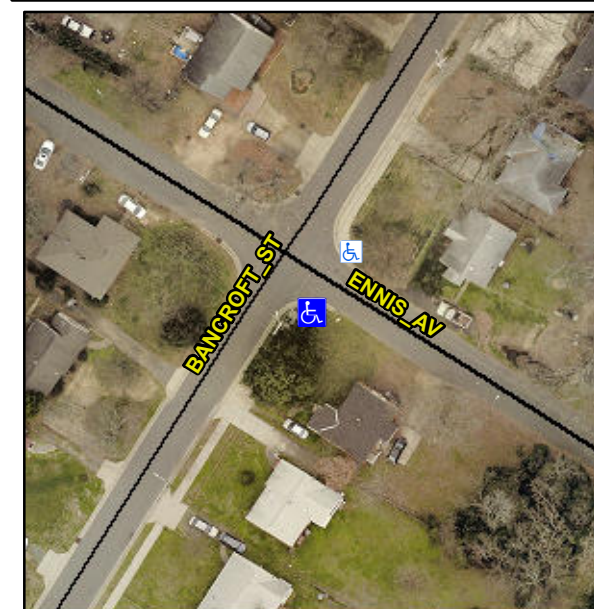
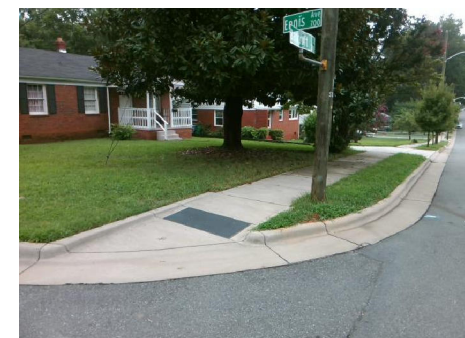
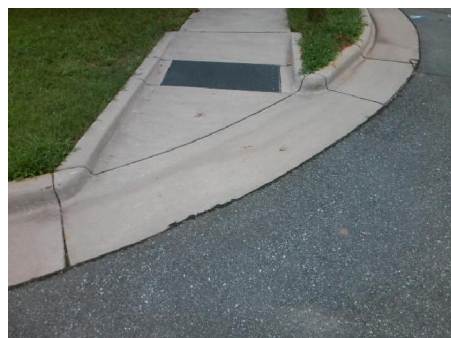
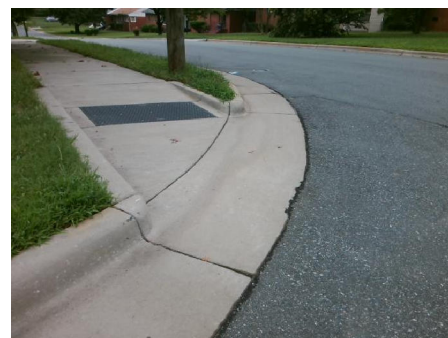
Compliance	Description	Data	Compliance	Description	Data
N/A	Ramp Length (in)	63.0	Yes	BlendTrans Slope (%)	4.5
Yes	Ramp Width (in)	58.0	No	BlendTrans XSlope (%)	5.4
N/A	Flare Type LT	N/A	N/A	Flare Type RT	N/A
N/A	Flare Slope LT (%)	N/A	N/A	Flare Slope RT (%)	N/A
N/A	Flare Traversable LT?	N/A	N/A	Flare Traversable RT?	N/A
N/A	Landing Length (in)	N/A	N/A	DWS Provided?	N/A
N/A	Landing Width (in)	N/A	N/A	DWS Contrast?	N/A
N/A	Landing Slope (%)	N/A	N/A	DWS Length (in)	N/A
N/A	Landing X Slope (%)	N/A	N/A	DWS Full Width?	N/A
N/A	Landing Curb? (Y/N)	N/A	N/A	DWS Offset (in)	N/A
N/A	Shared Landing?	N/A			
N/A	Gutter Ponding?	N/A	N/A	Gutter Slope (%)	N/A
N/A	Gutter Lip Ht (in)	N/A	N/A	Gutter X Slope (%)	N/A
N/A	Painted X Walk1?	No	N/A	Painted X Walk2?	N/A
	X Walk 1 Direction	To NE		X Walk 2 Direction	N/A
	X Walk 1 Width (in)	N/A		X Walk 2 Width (in)	N/A
	X Walk 1 Slope (%)	3.1		X Walk 2 Slope (%)	N/A
	X Walk 1 X Slope (%)	0.2		X Walk 2 X Slope (%)	N/A

N/A	Ramp inside XWalk1?	N/A	N/A	Ramp inside XWalk2?	N/A
	Road Slope (%)	0.2		Clear Space?	N/A
	Road X Slope (%)	3.1	N/A	Clear Space to XWalk (in)	N/A
N/A	Any Obstructions?	N/A	N/A	Storm Grate/Utility Hazard?	N/A
	Obstruction Type			Storm Grate/Utility Type	
		N/A			N/A
			Yes	Surface Condition? (G/P)	Good
			N/A	Curb Slope (%)	3.2

Remove & Replace Curb Ramp With Two New Directional Ramps or Equivalent.

R304.5.3
