# Access Compliance Report

## Public Rights-of-Way

### (Curb Ramps)

Intersection ID: 3991	Main Street: BRIDGEPATH_TL	Cross Street: DOWNING_CREEK_DR	Location: W
ADA ID: 66B74E145DB7	Ramp Type: Directional1	Initial Pass/Fail: Fail	Overall Compliance: No
Severity Score: 21.25			
Codes/Mitigation Info/Possible Solution		Field Measurements/Component Compliance

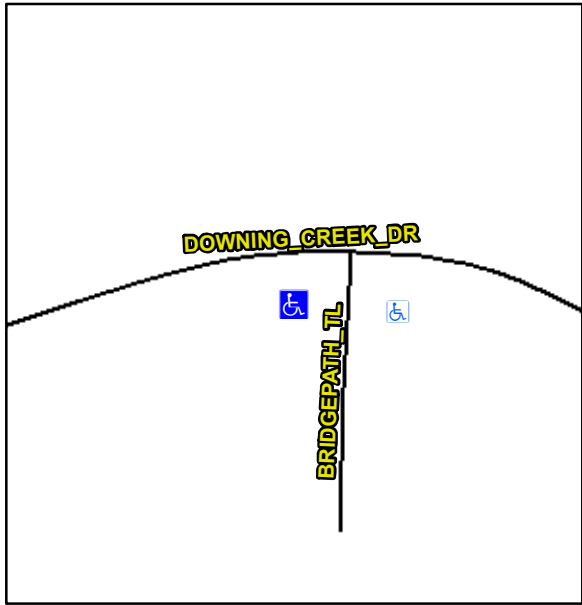
Compliance	Description	Data	Compliance	Description	Data
N/A	Ramp Length (in)	46.0	N/A	Grade Break?	N/A
No	Ramp Width (in)	40.5	N/A	Grade Break Slope (%)	0.0
Yes	Ramp Slope (%)	5.2	N/A	Grade Break XSlope (%)	0.0
No	Ramp XSlope (%)	6.4			
N/A	Flare Type LT	N/A	N/A	Flare Type RT	N/A
N/A	Flare Slope LT (%)	N/A	N/A	Flare Slope RT (%)	0.0
N/A	Flare Traversable LT?	N/A	N/A	Flare Traversable RT?	N/A
N/A	Landing Length (in)	0.0	N/A	DWS Provided?	N/A
N/A	Landing Width (in)	0.0	N/A	DWS Contrast?	N/A
N/A	Landing Slope (%)	0.0	N/A	DWS Length (in)	N/A
N/A	Landing X Slope (%)	0.0	N/A	DWS Full Width?	N/A
N/A	Landing Curb? (Y/N)	N/A	N/A	DWS Offset LT (in)	N/A
N/A	Shared Landing?	N/A	N/A	DWS Offset RT (in)	N/A
N/A	Gutter Ponding?	0.0	N/A	Gutter Slope (%)	N/A
N/A	Gutter Lip Ht (in)	0.0	N/A	Gutter X Slope (%)	N/A
N/A	Painted X Walk1?	No		Road Slope (%)	4.7
	X Walk 1 Direction	To NE		Road X Slope (%)	5.2
	X Walk 1 Width (in)	N/A		Clear Space?	N/A

X Walk 1 Slope (%)	4.7	N/A	Clear Space to XWalk (in)	N/A
	X Walk 1 X Slope (%)	5.2	N/A	Storm Grate/Utility Hazard?	N/A
N/A	Ramp inside XWalk1?	N/A		Storm Grate/Utility Type	
N/A	Any Obstructions?	N/A			N/A
	Obstruction Type		Yes	Surface Condition? (G/P)	Good
		N/A	N/A	Curb Slope (%)	18.4

Possible Solutions:				
	<b>Remove &amp; Replace Entire Ramp.</b>				
	Surveyor Notes:				
	<b>N/A</b>				
	PROW/ADA:				
	<b>R304.5.1, R304.5.3</b>				
	Street 1 Name	<b>BRIDGEPATH TL</b>			
	Stop Condition-Street 1	<b>StopSign</b>			
	Street 2 Name	<b>N/A</b>			
	Stop Condition-Street 2	<b>N/A</b>			
Total Cost:		\$	<b>1600.00</b>

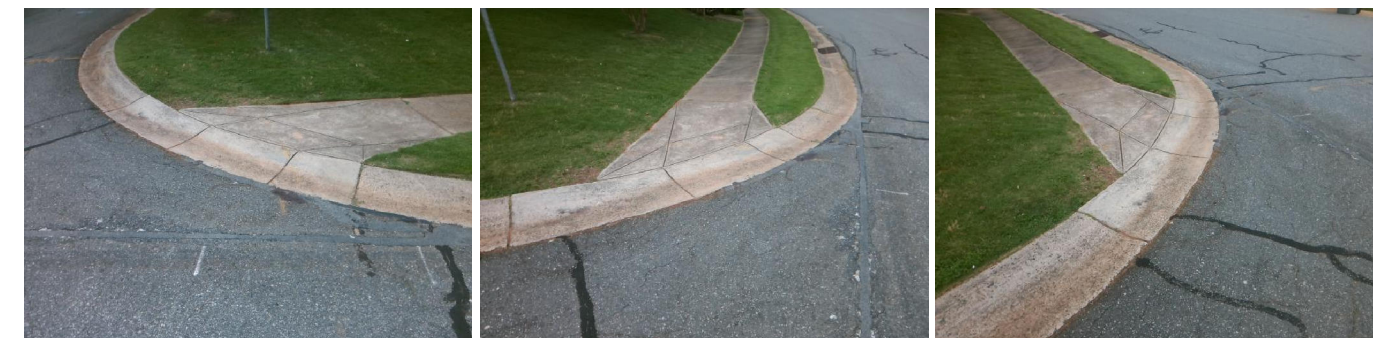
Compliance	Description	Data	Compliance	Description	Data
N/A	Ramp Length (in)	46.0	N/A	Grade Break?	N/A
No	Ramp Width (in)	40.5	N/A	Grade Break Slope (%)	0.0
Yes	Ramp Slope (%)	5.2	N/A	Grade Break XSlope (%)	0.0
No	Ramp XSlope (%)	6.4			
N/A	Flare Type LT	N/A	N/A	Flare Type RT	N/A
N/A	Flare Slope LT (%)	N/A	N/A	Flare Slope RT (%)	0.0
N/A	Flare Traversable LT?	N/A	N/A	Flare Traversable RT?	N/A
N/A	Landing Length (in)	0.0	N/A	DWS Provided?	N/A
N/A	Landing Width (in)	0.0	N/A	DWS Contrast?	N/A
N/A	Landing Slope (%)	0.0	N/A	DWS Length (in)	N/A
N/A	Landing X Slope (%)	0.0	N/A	DWS Full Width?	N/A
N/A	Landing Curb? (Y/N)	N/A	N/A	DWS Offset LT (in)	N/A
N/A	Shared Landing?	N/A	N/A	DWS Offset RT (in)	N/A
N/A	Gutter Ponding?	0.0	N/A	Gutter Slope (%)	N/A
N/A	Gutter Lip Ht (in)	0.0	N/A	Gutter X Slope (%)	N/A
N/A	Painted X Walk1?	No		Road Slope (%)	4.7
	X Walk 1 Direction	To NE		Road X Slope (%)	5.2
	X Walk 1 Width (in)	N/A		Clear Space?	N/A

X Walk 1 Slope (%)	4.7	N/A	Clear Space to XWalk (in)	N/A
	X Walk 1 X Slope (%)	5.2	N/A	Storm Grate/Utility Hazard?	N/A
N/A	Ramp inside XWalk1?	N/A		Storm Grate/Utility Type	
N/A	Any Obstructions?	N/A			N/A
	Obstruction Type		Yes	Surface Condition? (G/P)	Good
			N/A	Curb Slope (%)	18.4
