# Access Compliance Report

## Public Rights-of-Way

### (Curb Ramps)

Intersection ID: 14633	Main Street: E_KINGSTON_AV	Cross Street: PARK_RD	Location:	N
ADA ID: 66C0B886EE0E	Ramp Type: Perp	Initial Pass/Fail: Fail	Overall Compliance: No	Severity Score: 1.25

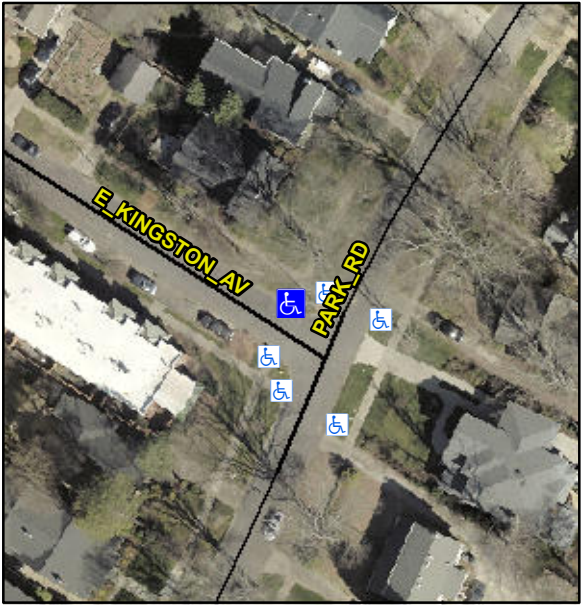
N/A	Shared Landing?	N/A			
		N/A	Gutter Ponding?	Yes	N/A	Gutter Slope (%)	N/A
		N/A	Gutter Lip Ht (in)	N/A	N/A	Gutter X Slope (%)	N/A
		N/A	Painted X Walk1?	No	N/A	Painted X Walk2?	N/A
			X Walk 1 Direction	To SW		X Walk 2 Direction	N/A
		N/A	X Walk 1 Width (in)	N/A	N/A	X Walk 2 Width (in)	N/A
			X Walk 1 Slope (%)	8.0		X Walk 2 Slope (%)	N/A
			X Walk 1 X Slope (%)	2.2		X Walk 2 X Slope (%)	N/A
		N/A	Ramp inside XWalk1?	N/A	N/A	Ramp inside XWalk2?	N/A
			Road Slope (%)	N/A	N/A	Clear Space?	N/A
			Road X Slope (%)	N/A	N/A	Clear Space to XWalk (in)	N/A
		N/A	Any Obstructions?	N/A	N/A	Storm Grate/Utility Hazard?	N/A
			Obstruction Type			Storm Grate/Utility Type	
				N/A			N/A
					Yes	Surface Condition? (G/P)	Good

Possible Solutions:	<b>Remove &amp; Replace Entire Ramp.</b>					
	Surveyor Notes:	N/A					
	PROW/ADA:	Not Found, R304.5.3					
	Street 1 Name	E KINGSTON AV					
	Stop Condition-Street 2	StopSign					
	Street 2 Name	N/A					
	Stop Condition-Street 1	N/A					
	Total Cost:	\$ 1850.00					
		Compliance	Description	Data	Compliance	Description	Data
		N/A	Ramp Length (in)	51.0	Yes	Ramp Slope (%)	7.6
		Yes	Ramp Width (in)	48.0	No	Ramp XSlope (%)	2.7
		N/A	Flare Type LT	N/A	N/A	Flare Type RT	N/A
		N/A	Flare Slope LT (%)	N/A	N/A	Flare Slope RT (%)	N/A
		N/A	Flare Traversable LT?	N/A	N/A	Flare Traversable RT?	N/A
		N/A	Landing Length (in)	N/A	N/A	DWS Provided?	N/A
		N/A	Landing Width (in)	N/A	N/A	DWS Contrast?	N/A
		N/A	Landing Slope (%)	N/A	N/A	DWS Length (in)	N/A
		N/A	Landing X Slope (%)	N/A	N/A	DWS Full Width?	N/A
		N/A	Landing Curb? (Y/N)	N/A	N/A	DWS Offset (in)	N/A
