# Access Compliance Report

## Public Rights-of-Way

### (Curb Ramps)

| Intersection ID: 27872 | Main Street: BALLANTYNE_COUNTRY_CLUB_DR | Cross Street: LETHCO_WY | Location: NW |

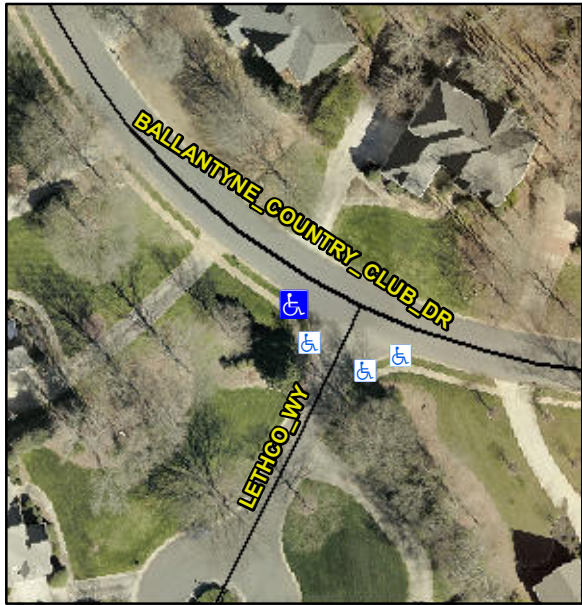
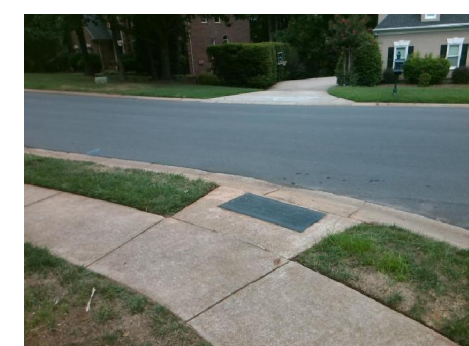
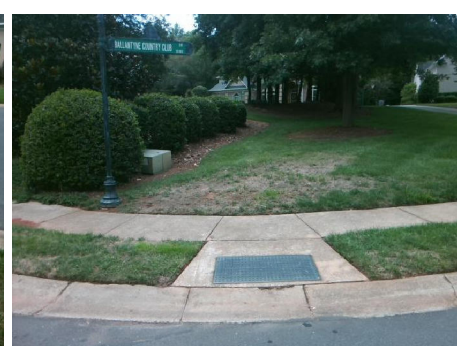
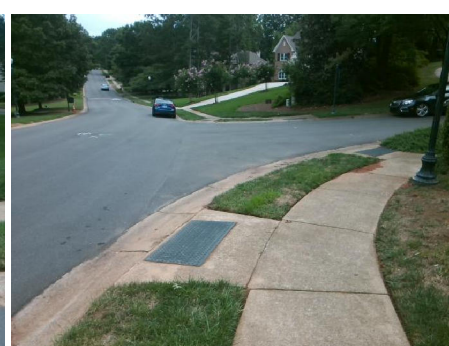
| ADA ID: 66CCB22C0913 | Ramp Type: Perp | Initial Pass/Fail: Fail | Overall Compliance: No |

Not Found, R304.2.2, R304.5.3

| Compliance | | Description | Data | Compliance | Description | Data |
|---|--|---|---|---|---|---|
| N/A | | Ramp Length (in) | 50.0 | No | Ramp Slope (%) | 10.3 |
| Yes | | Ramp Width (in) | 48.0 | No | Ramp XSlope (%) | 2.9 |

Remove & Replace Entire Ramp.

1850.00
